# Assessment of bacteria participation in deposits formation inside the steel pipeline through X-ray diffraction studies

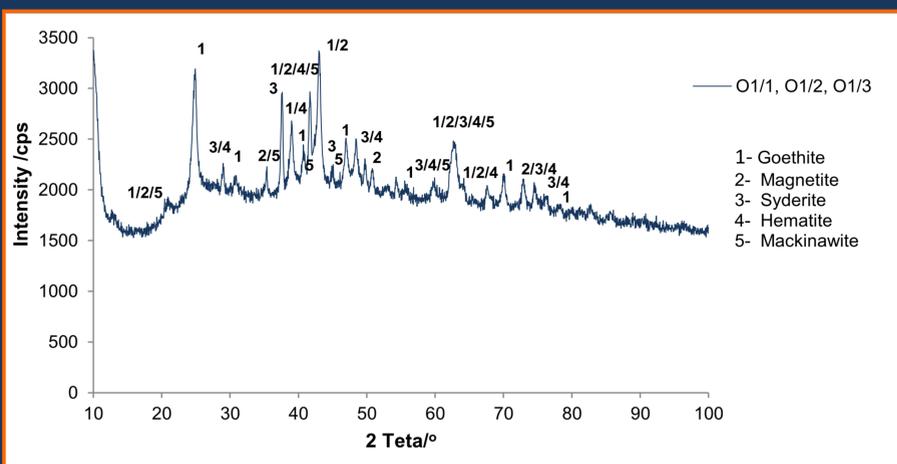
- The presence of mackinawite in the naturally dehydrated deposits which have been scrubbed from inside the pipe beginning can be an indicative of the activity of sulfate reducing bacteria (SRB) in analyzed sample.

- Simultaneous presence of mackinawite and siderite can indicate that mechanism called Electrical Microbially Influenced Corrosion (EMIC) occurred during formation of deposits in analysed samples collected from inside of pipe beginning, where certain SRB strains have utilized electrons from the process of metallic iron oxidation.

- Simultaneous presence of anaerobic corrosion products (residues) such as mackinawite and ferric oxides (magnetite, hematite) may suggest that the secondary oxidation processes occurred in analysed samples, and that anaerobic MIC was replaced by aerobic MIC.

Fig.1. XRD pattern of naturally dehydrated deposits which have been scraped from beginning part of corroded steel pipe.

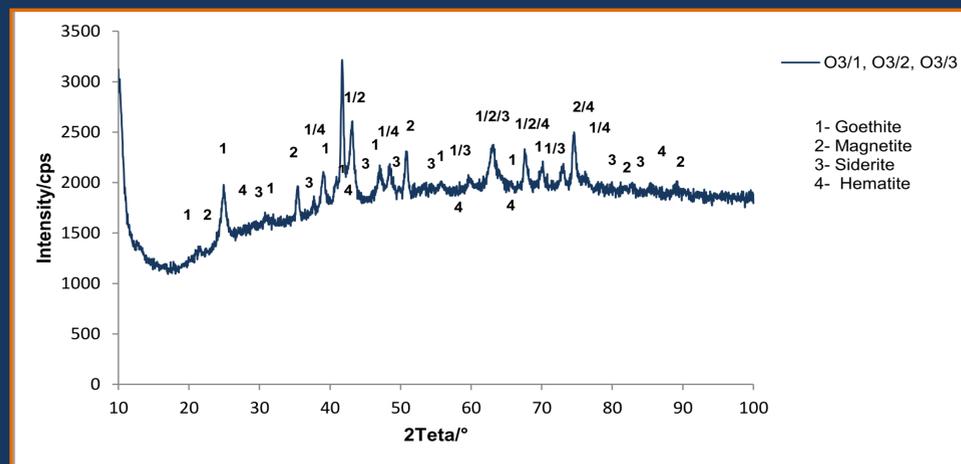
- The mackinawite as a product of the SRB activity was not present in deposits collected from the middle and end of pipe.

Fig.2. XRD pattern of naturally dehydrated deposits which have been scraped from the middle part of corroded steel pipe.

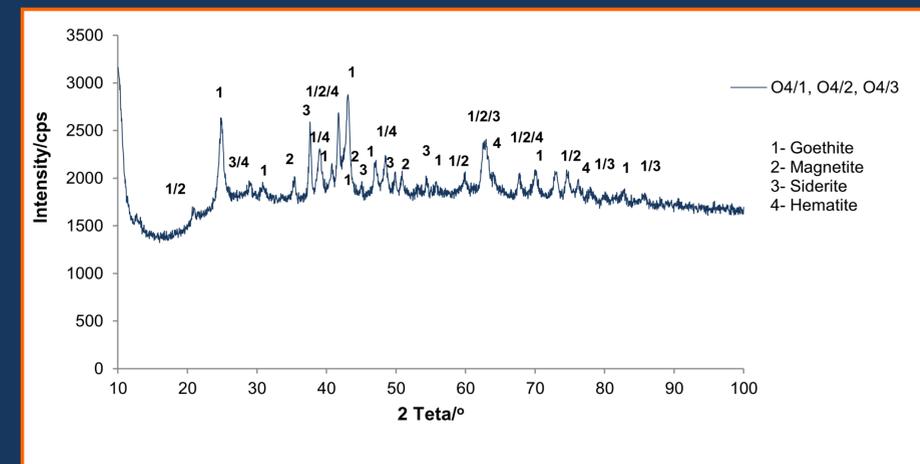
Fig.3. XRD pattern of naturally dehydrated deposits which have been scraped from the end part of corroded steel pipe.
