# Steel Structures Congress

“CFRP Strengthening and Rehabilitation of Corroded Steel Pipelines Under Combined Bending and Bearing”

Dr Mohamed Elchalakani

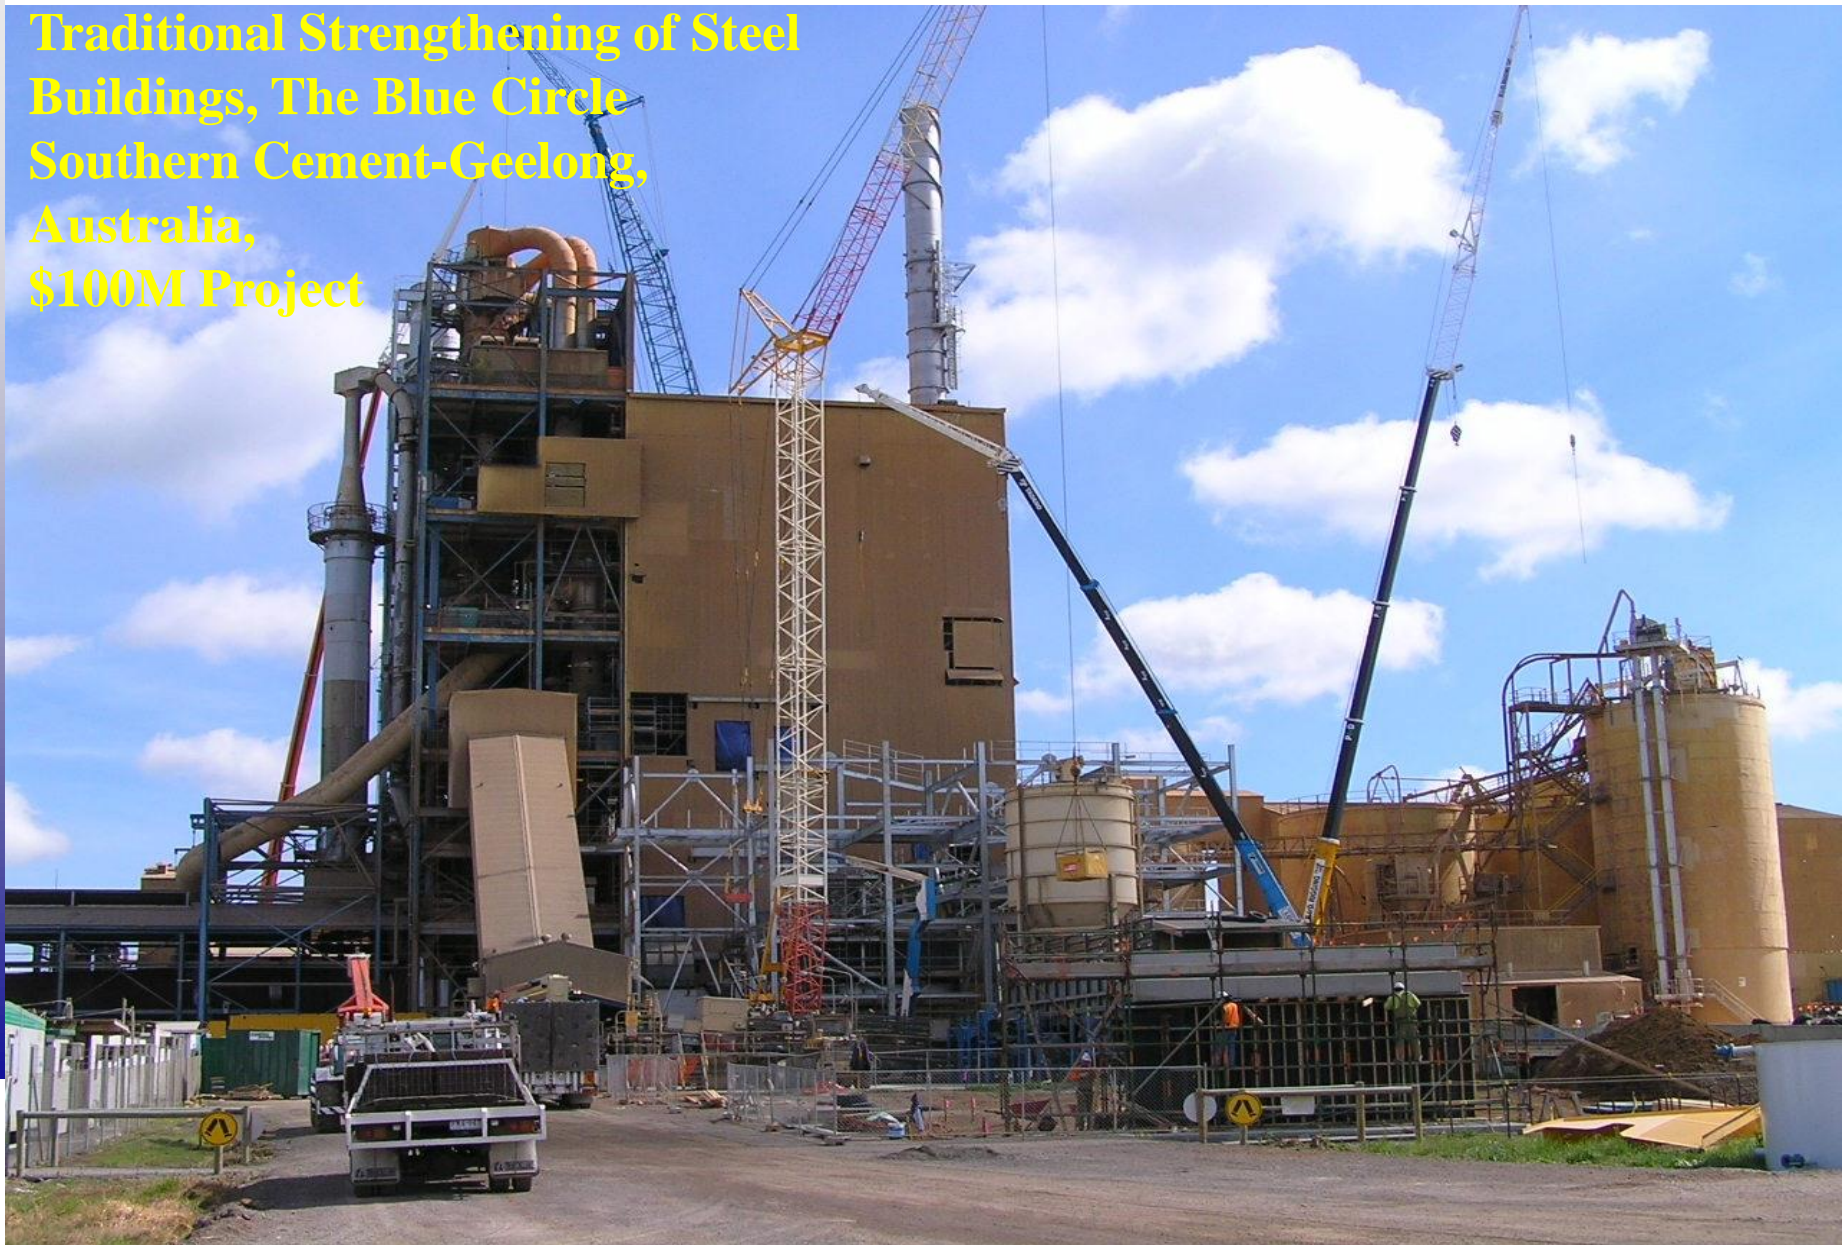
**Traditional Strengthening of Steel Buildings, The Blue Circle Southern Cement-Geelong, Australia, \$100M Project**

*Elchalakani, M. (2004), Design of Raw Mill Stack, New Preheater, New Raw Mill, Connell Wagner, Blue Circle Cement, Waurn Ponds, Geelong, Victoria, Australia*

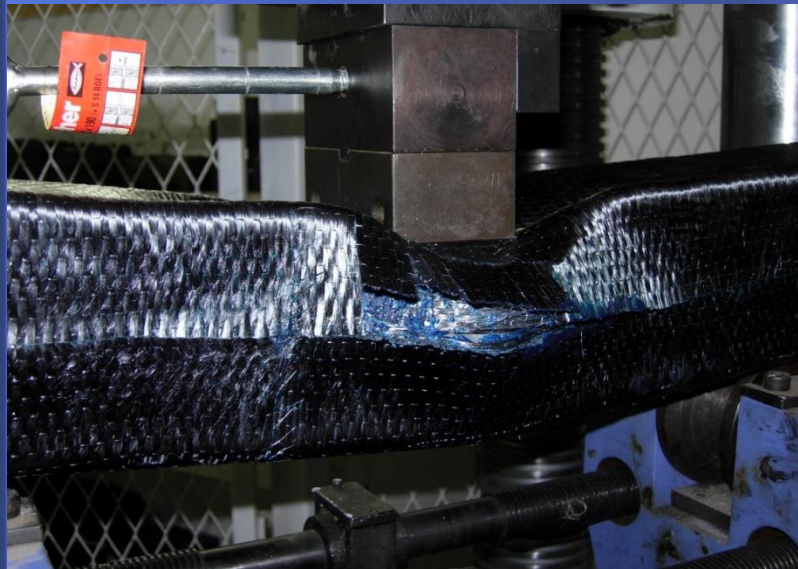
# Strengthening Series-Failure Modes

## Only the mid-span kink was observed

*The failure modes observed includes;*

- a) a ductile in-plane symmetric collapse mode under large bending deformation with the top flange forming a deep kink at mid-span associated with web crippling) was observed ;*
- b) The mixed mode where a LTB mode formed together with a deep mid-flange kink and web crippling was not observed*
- c) Pure LTB mode as  $L_e/r_y$  is small was not observed*

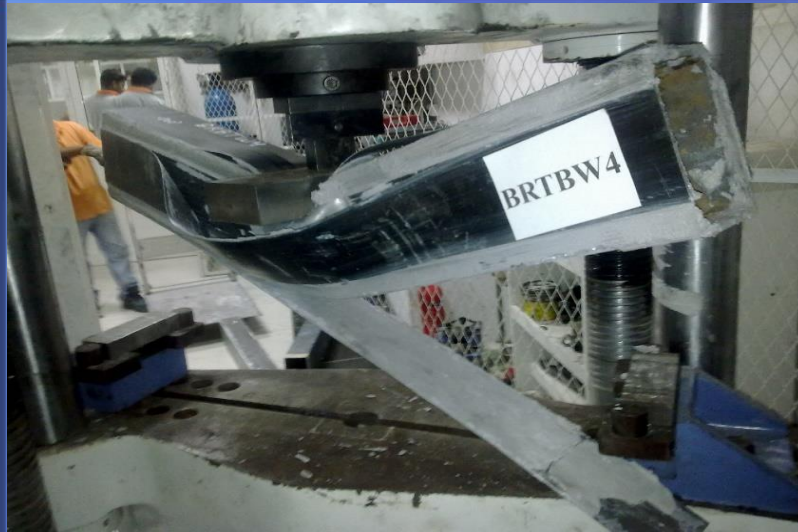
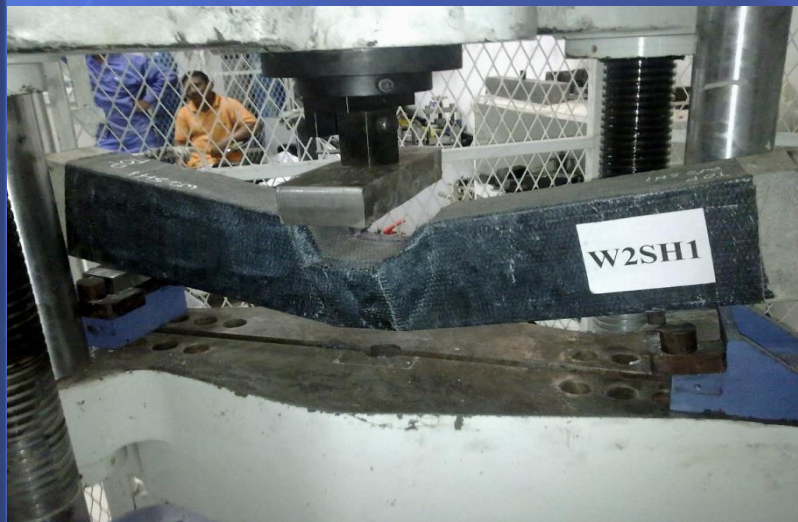
# Rehabilitation Series-Failure Modes

Only the kink and mixed mode were observed

The failure modes observed includes:

- a) a ductile in-plane symmetric collapse mode under large bending deformation with the top flange forming a deep kink at mid-span associated with web crippling); was observed
- b) The mixed mode where a LTB mode formed together with a deep mid-flange kink and web crippling for  $L=900$  was observed
- c) Pure LTB mode as  $L_e/r_y$  is small was not observed

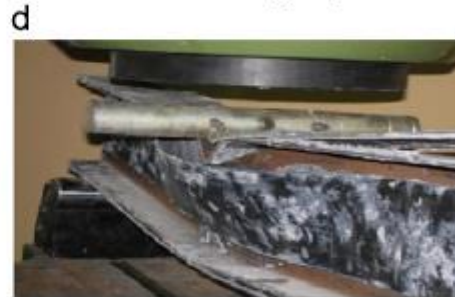
d mixed mode failure (with debonding at compression and tension flange and on web)

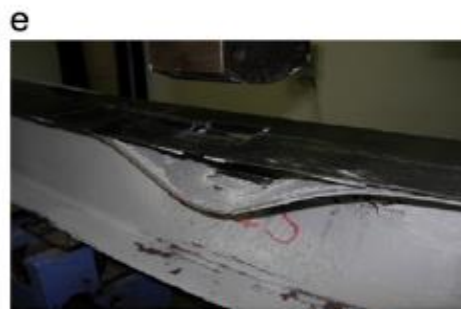
e compression flange debonding

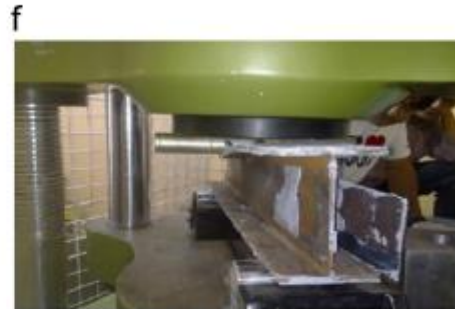
f web debonding

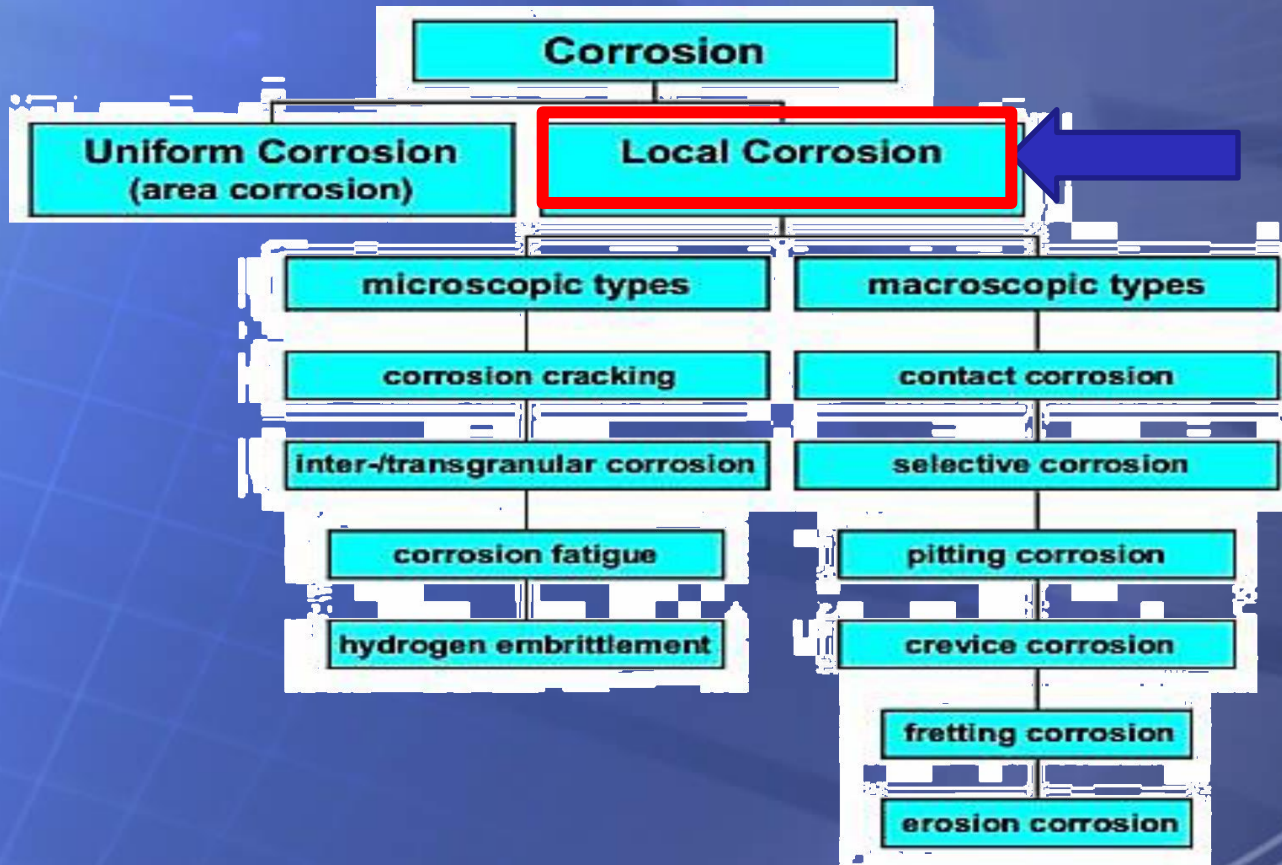
# Types of corrosion

Local corrosion is the subject of this paper

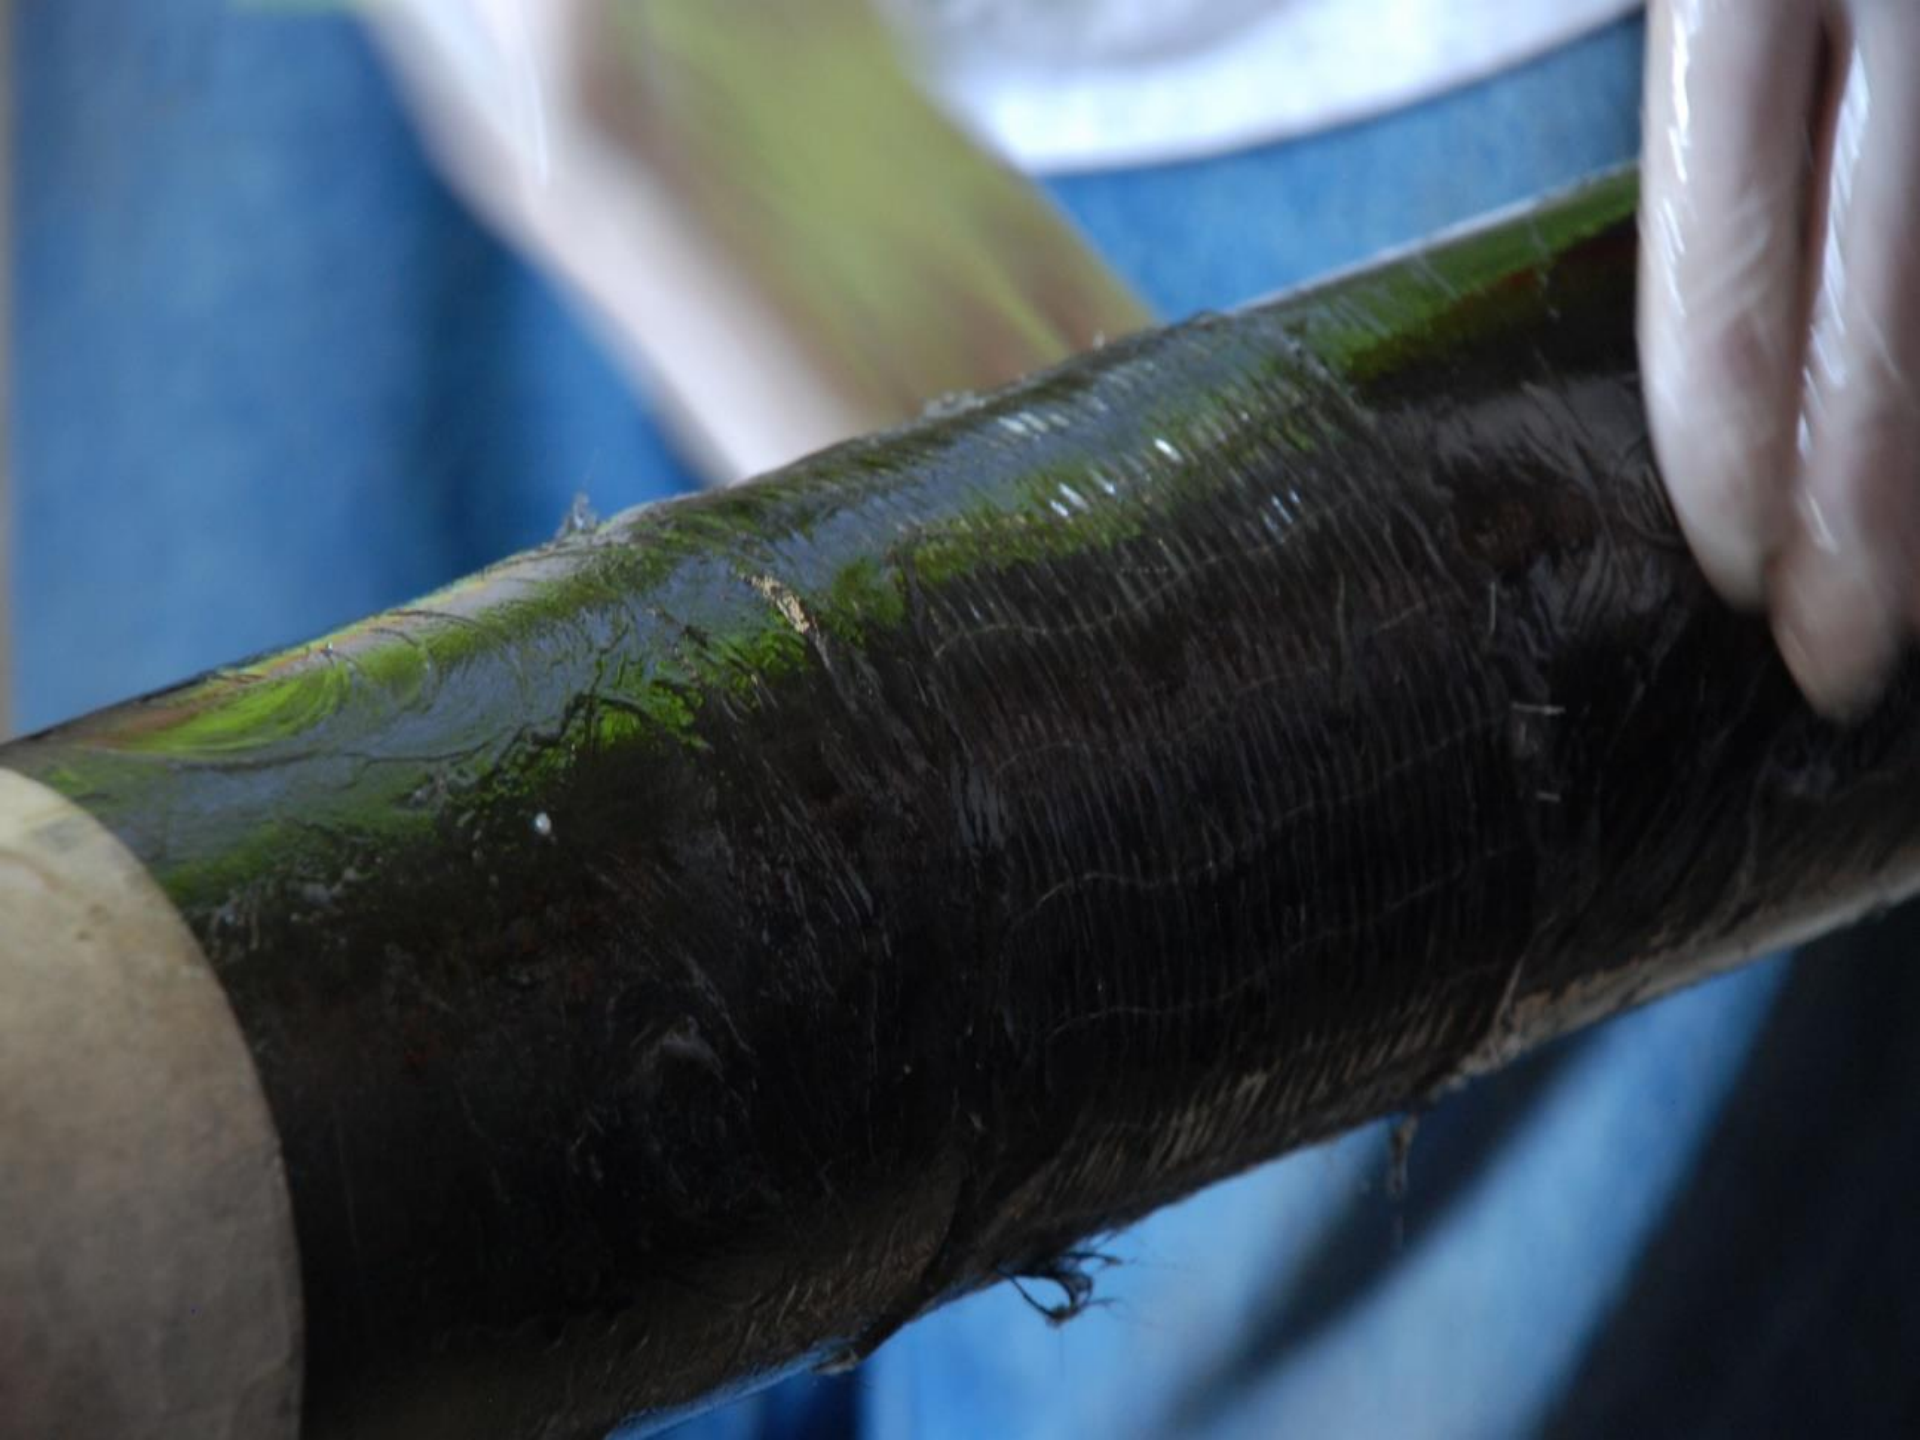
## Transverse

## Saturated

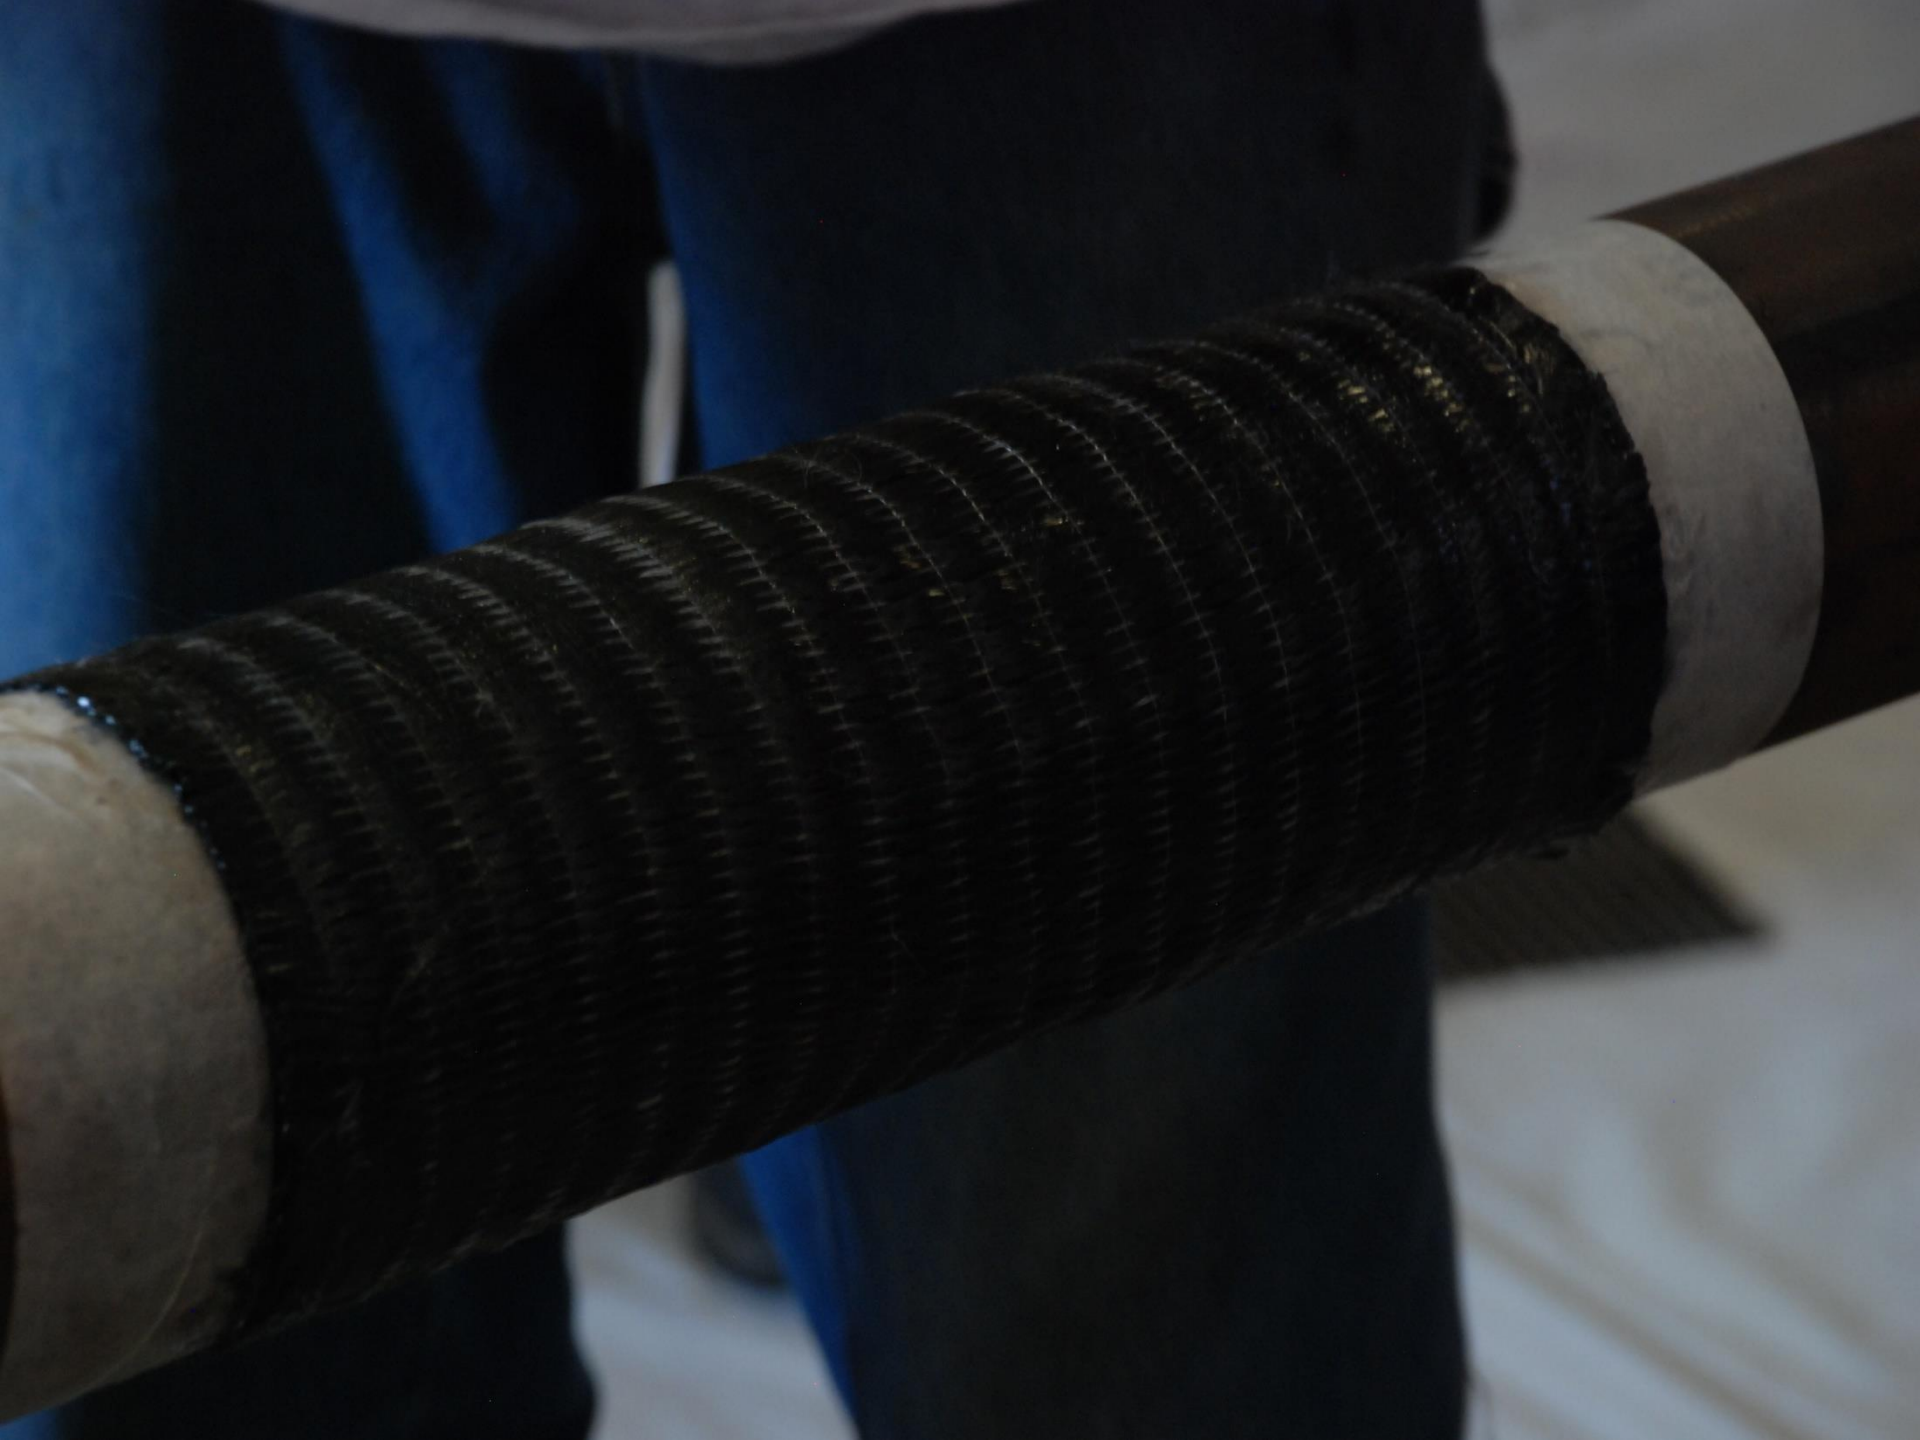
## Longitudinal

## Saturated

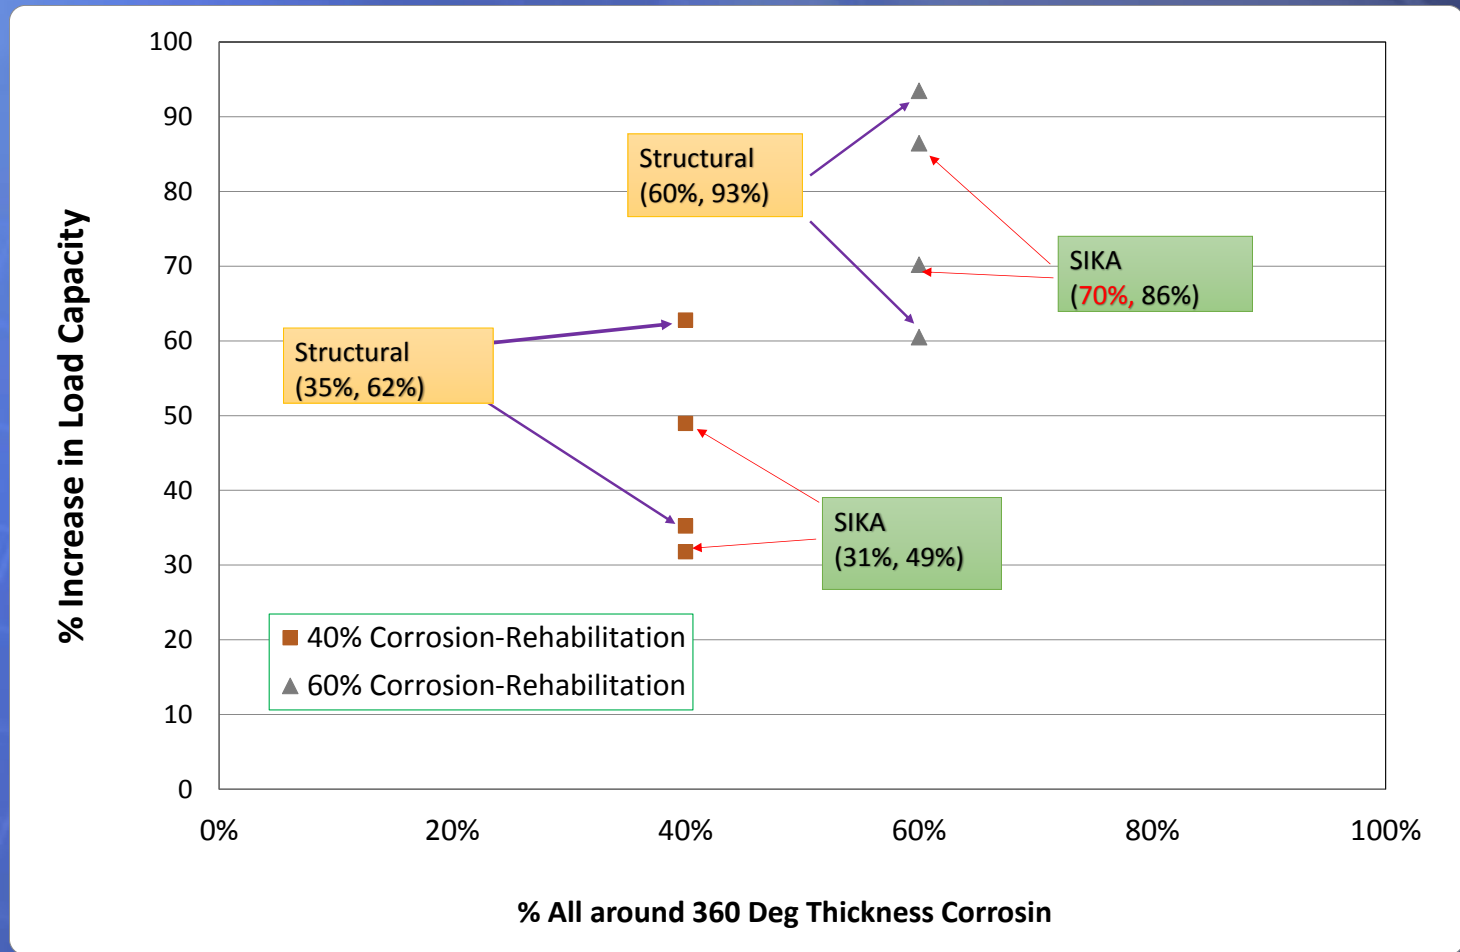
# Structural Technology wrapping System Provided higher strength

# Gain in Strength due to CFRP

The percent increase in strength was mostly affected by the corrosion level where the maximum gain was **434%** which was obtained for the most severe **80%** corrosion in the wall thickness. The average increase in the load carrying capacity was 97% and 169% for the rehabilitation and strengthening series, respectively.

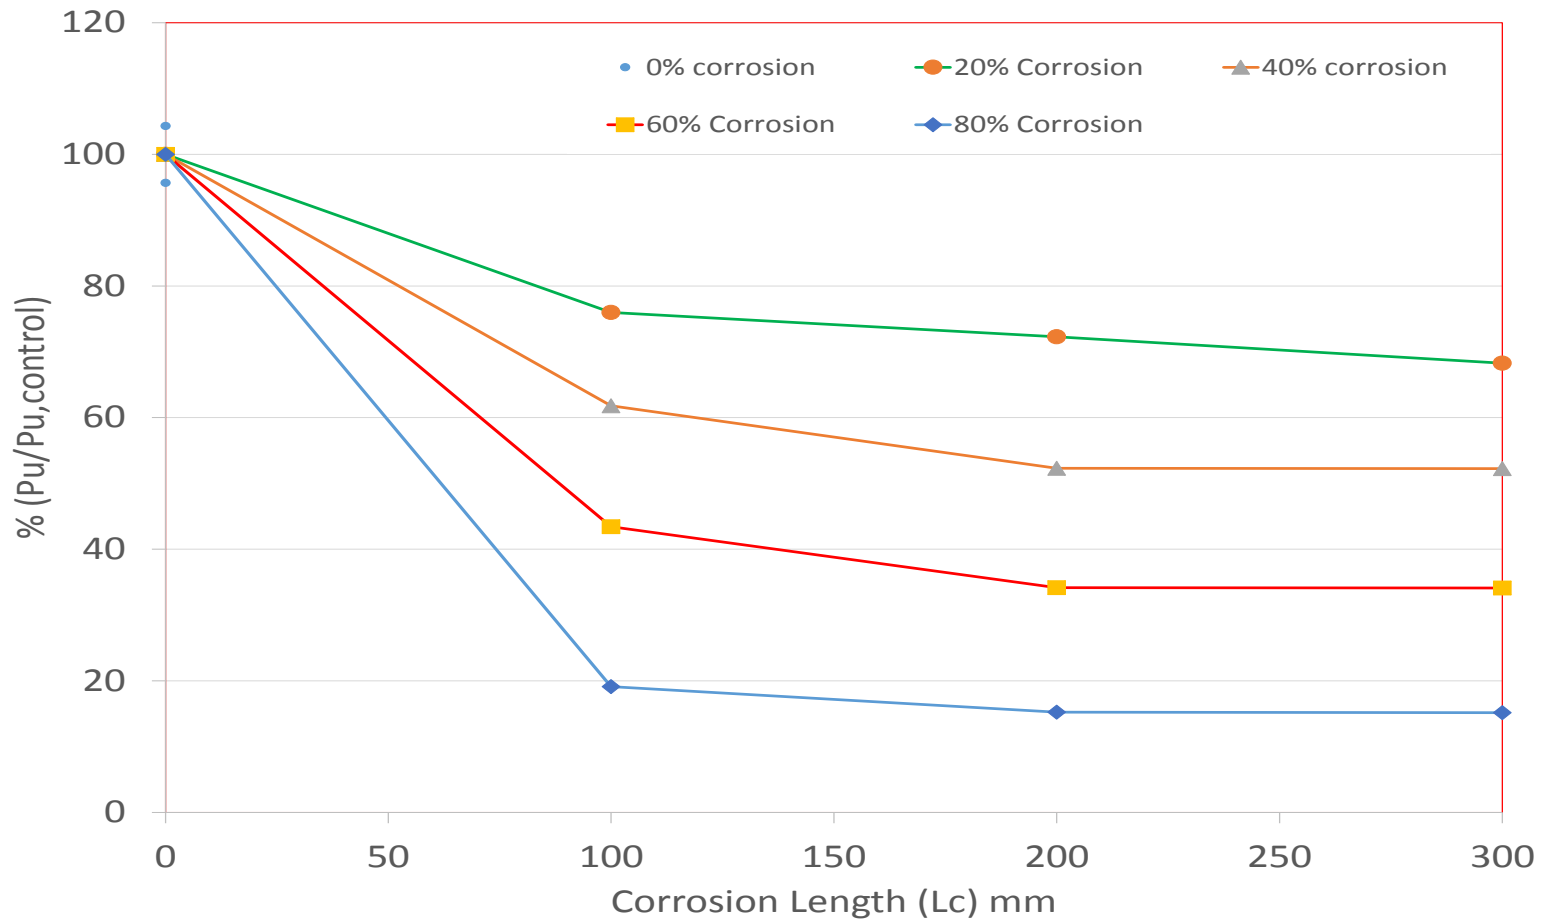
## Effect of the corrosion length ( $L_c$ ) on the normalised strength ( $\%P_u/P_{u,control}$ )

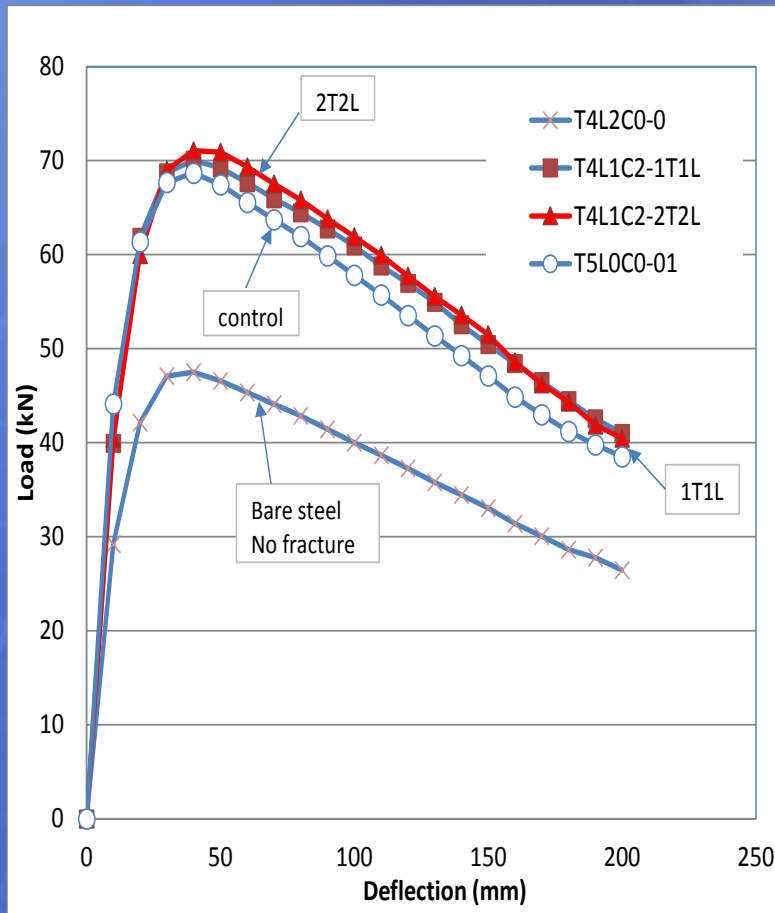
**20% Corrosion**

# Load-deflection Curves

The stiffness and **capacity** of the un-corroded control specimen **was fully restored** for the repaired specimens with **20% corrosion** in the wall. However, for higher levels of corrosion of 40% to 80% such stiffness and capacity were not fully restored. Thus adding more CFRP sheets in the circumferential and longitudinal directions may restore the un-corroded stiffness and capacity for 40% to 80% corrosion.

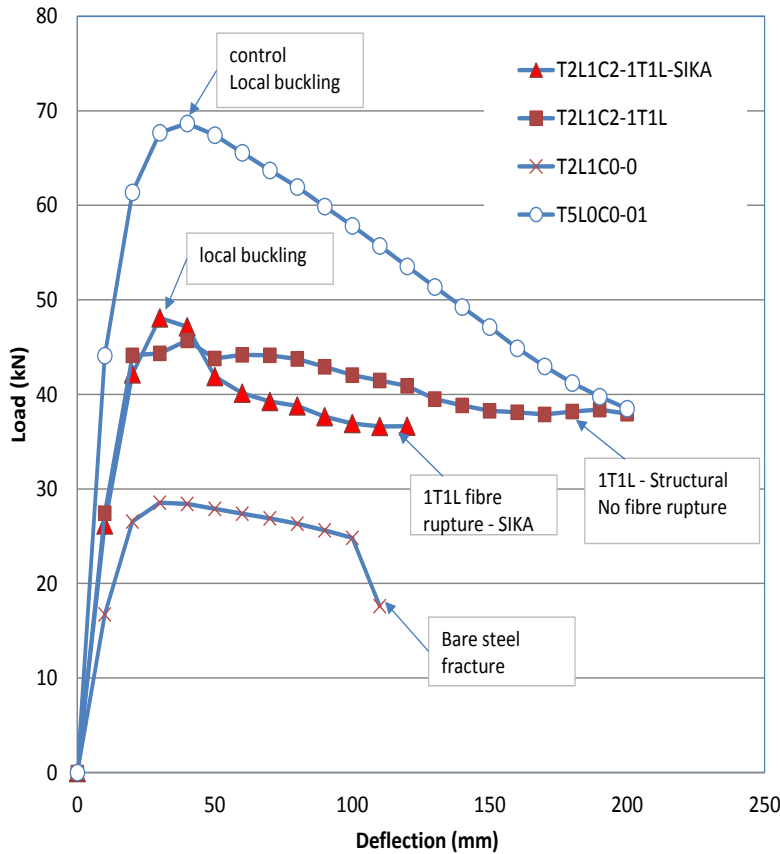
60% Corrosion

# Load-deflection Curves

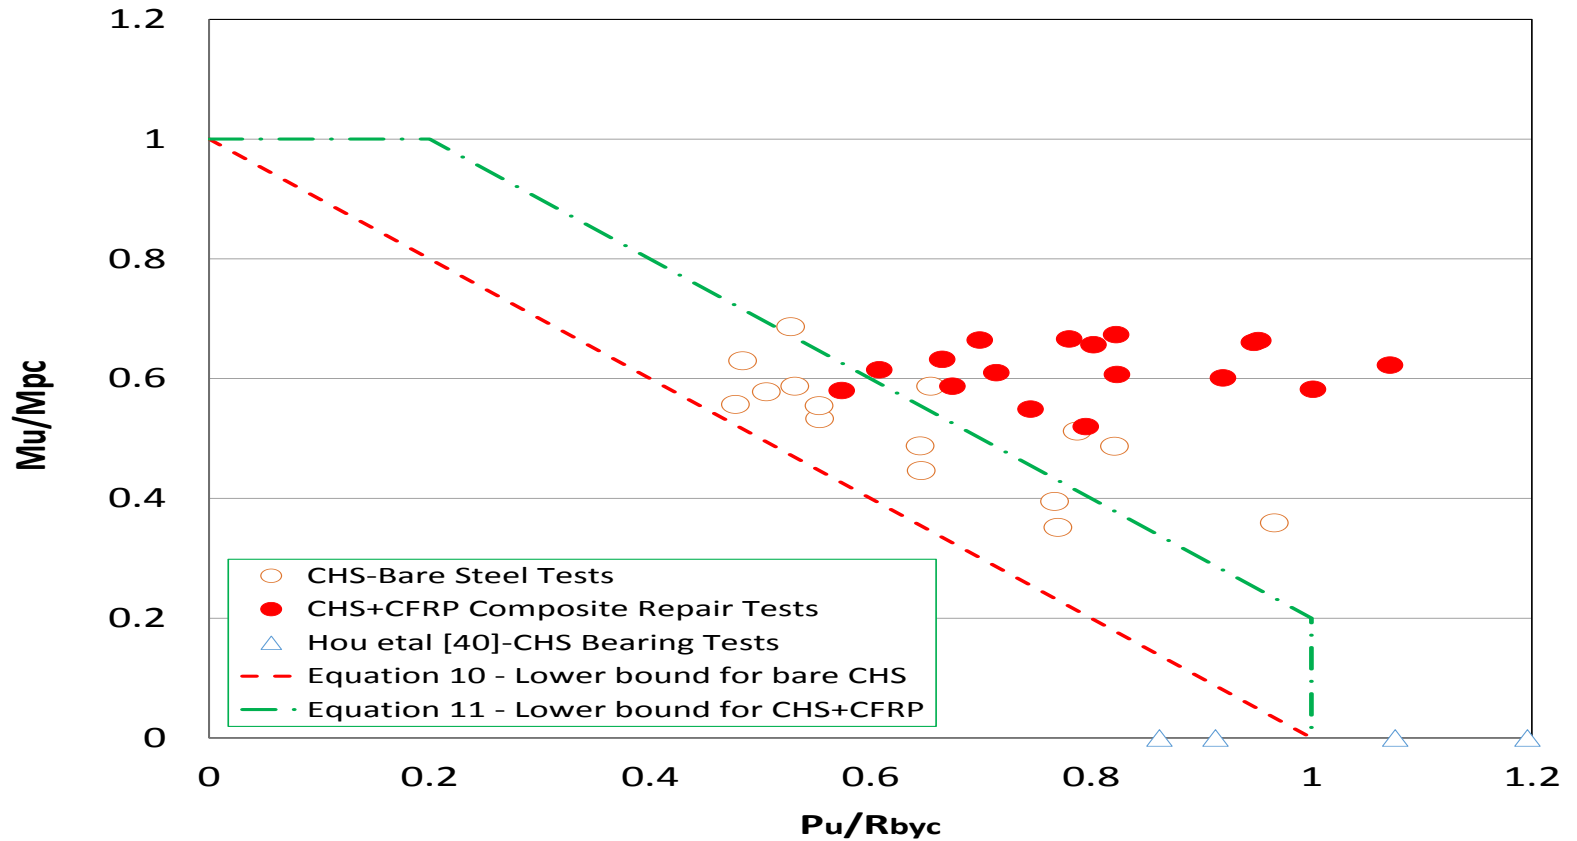
$$\left( \frac{P_u}{R_{byc}} \right) + \left( \frac{M_u}{M_{pc}} \right) \leq 1.0 \text{ for bare CHS where } D_0/t_s = 164\epsilon^2 \text{ and } L_c/D_0 = 3.0 \quad (10)$$

$$\left( \frac{P_u}{R_{byc}} \right) + \left( \frac{M_u}{M_{pc}} \right) \leq 1.2 \text{ for repaired CHS using CFRP where } D_0/t_s = 164\epsilon^2 \text{ and } L_c/D_0 = 3.0 \quad (11)$$

Design equations based on the bare and composite section properties were derived to predict the strength of bare and repaired CHS using CFRP under combined bending and bearing.
