**A PRESENTATION
ON
SEA-LEVEL RISE AND COASTAL
SUBMERGENCE ALONG THE SOUTH
–EAST COAST OF NIGERIA**

SAVIOUR P. UDO-AKUAIBIT

at the 2nd International Conference on Oceanography, Las Vegas, USA., July 21-23, 2014.

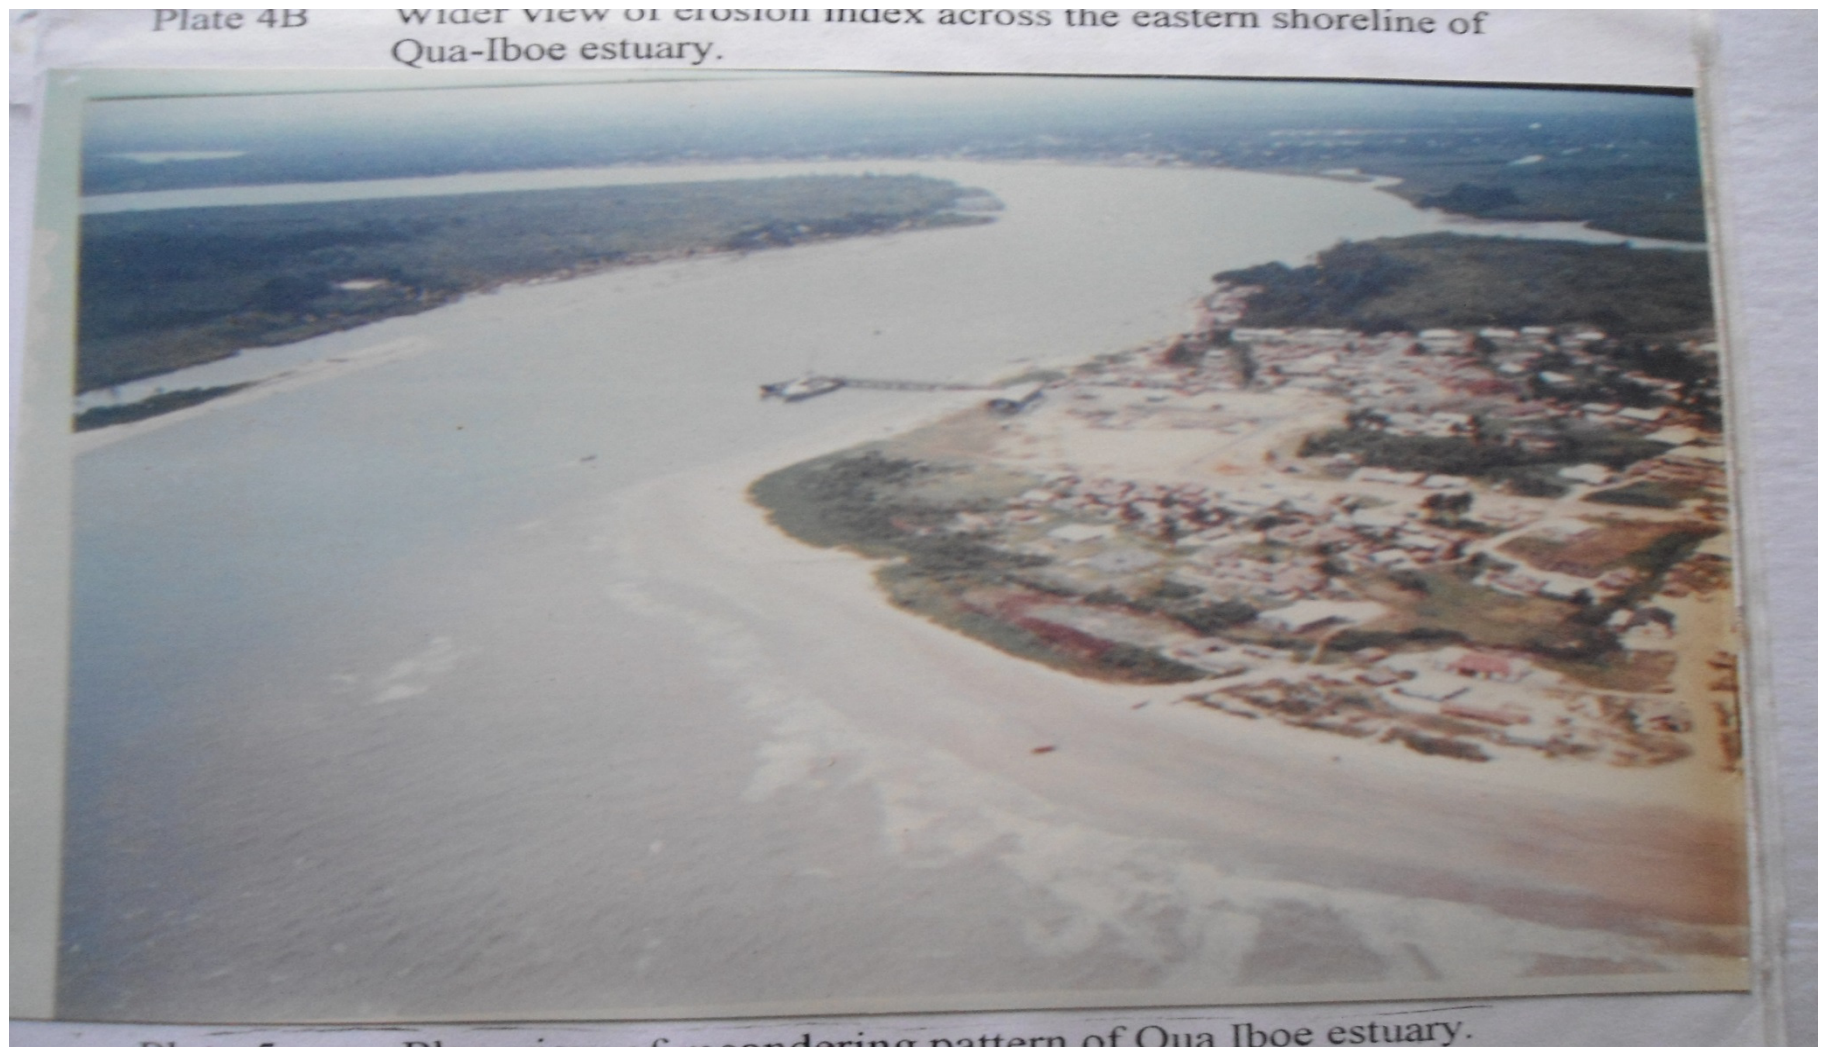
Plate 1: Aerial photo of Qua-Iboe Estuary in 2002

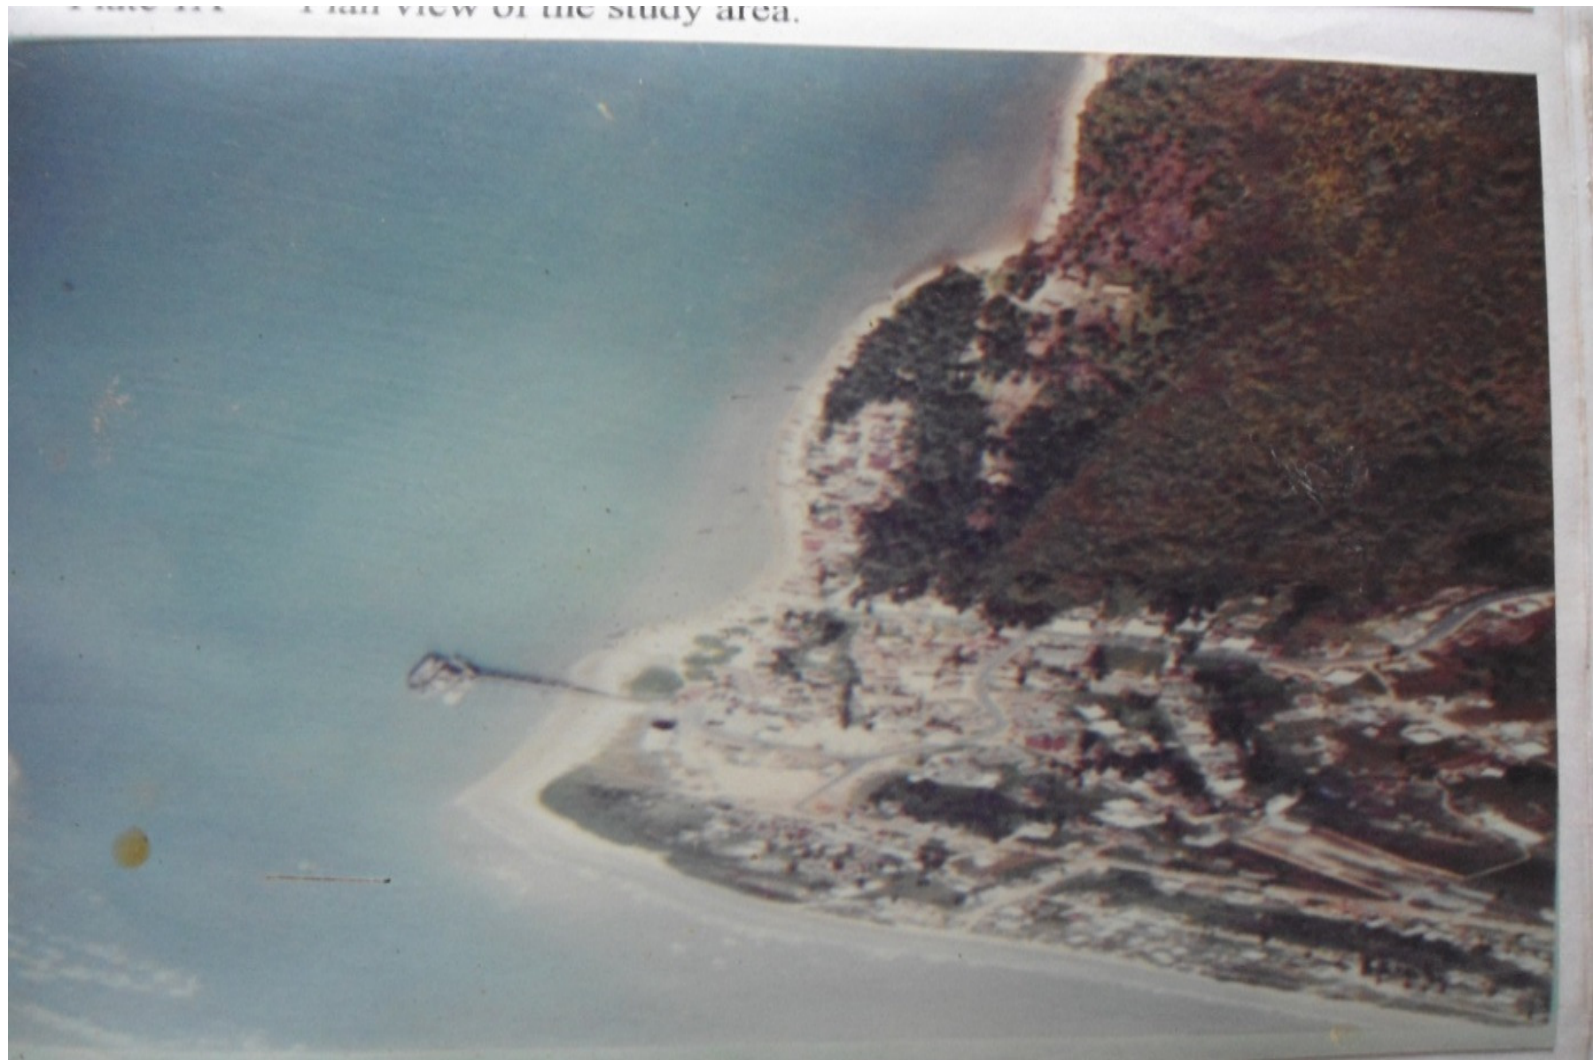
Plate 2: Aerial photo of Qua-Iboe estuary showing areas of severe erosion in 2002

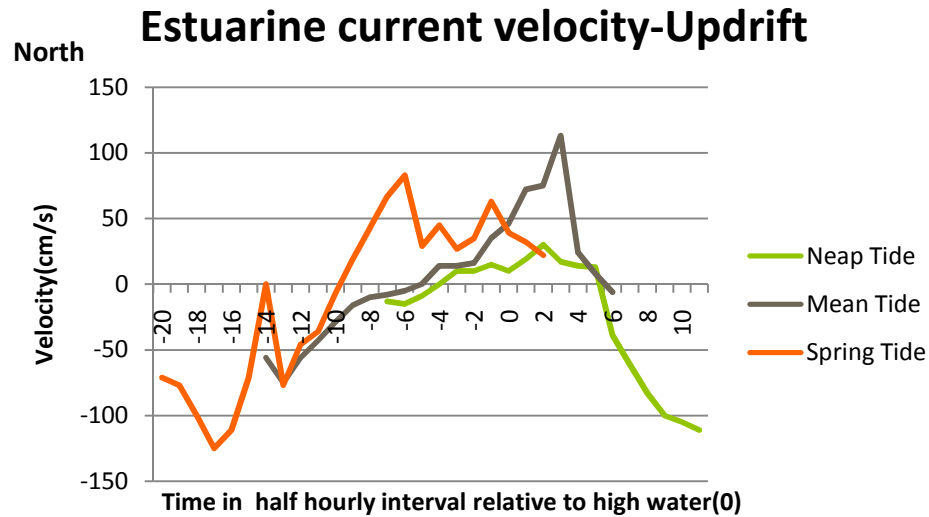
Fig.4.Estuarine current velocity-Updrift

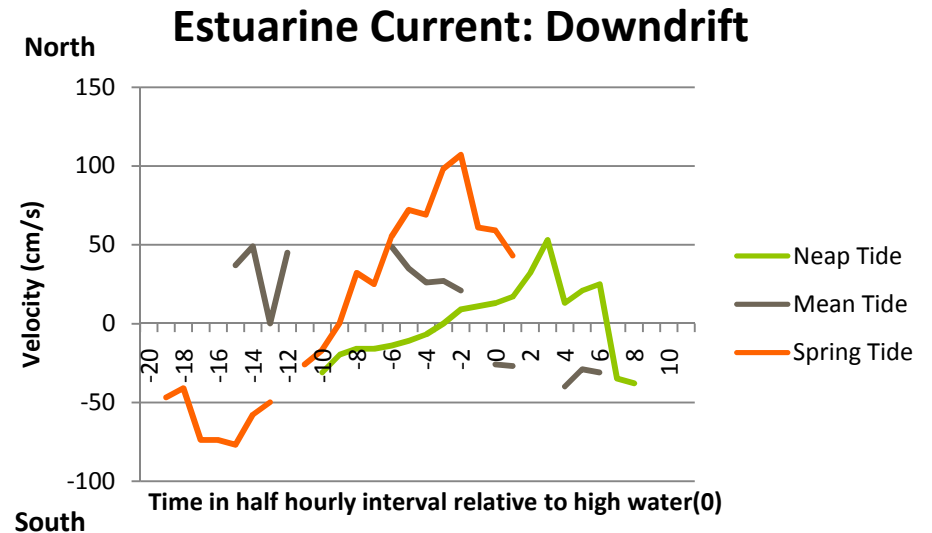
Fig.5.Estuarine current velocity:downdrift

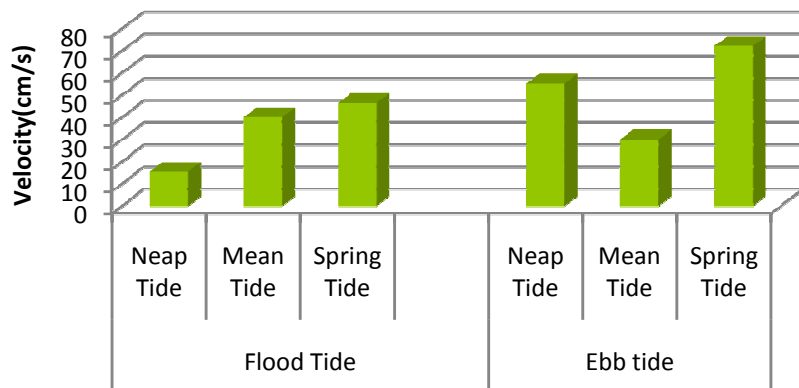
Fig.6.Average Flow Velocity:Estuary updrift

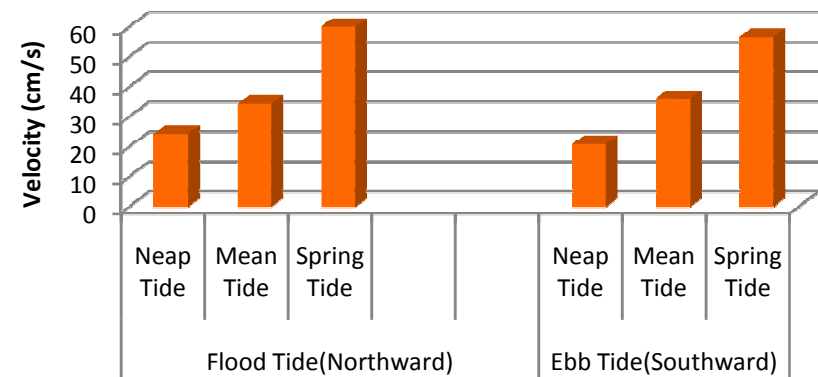
Fig.7 Average Flow Velocity: Estuary Downdrift

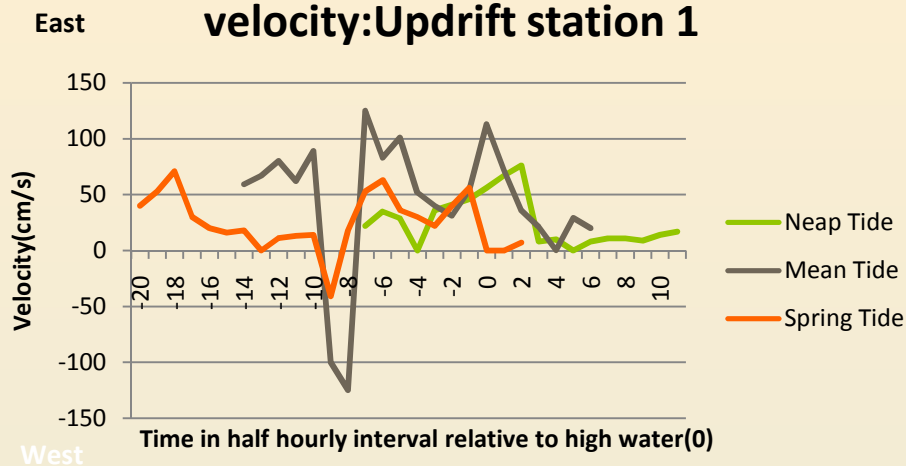
Fig. 8: Longshore current velocity:Updrift station 1

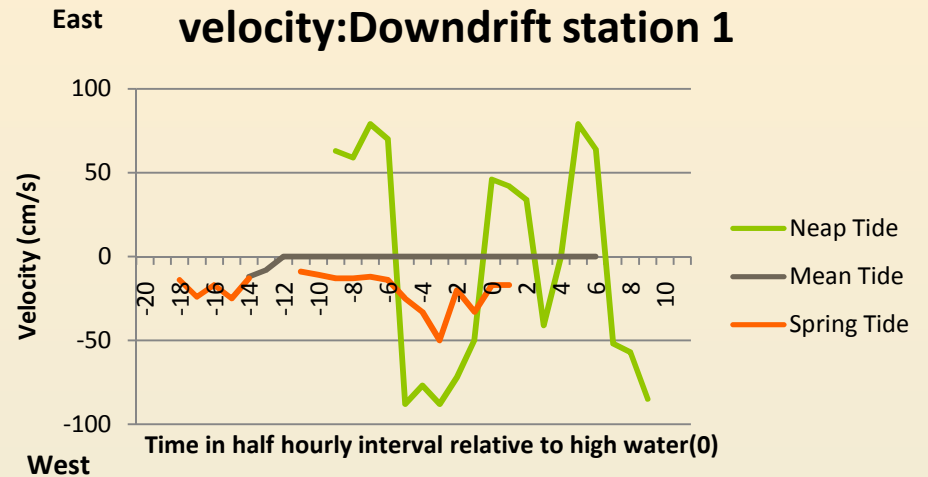
Fig. 9: Longshore current velocity:Downdrift station 1

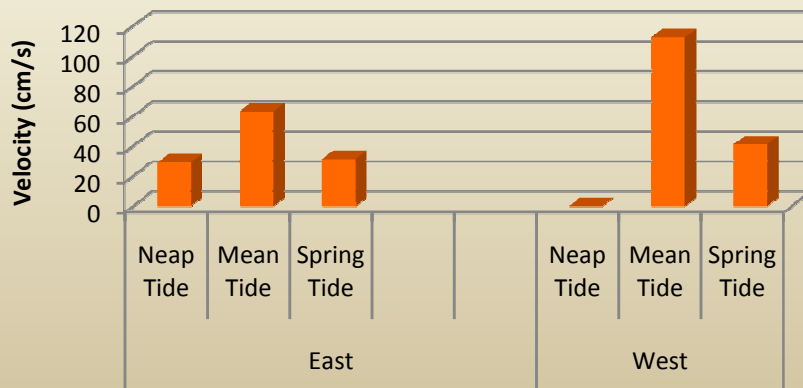
Fig.10: Average Longshore Current Velocity: Updrift-Station 1

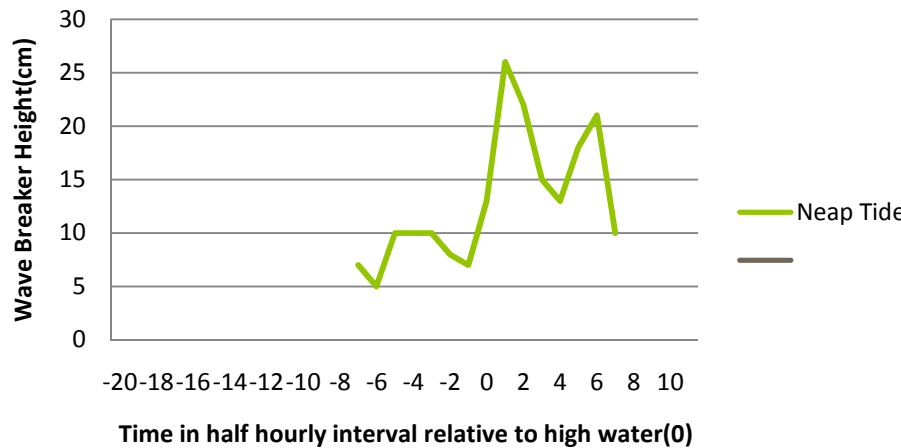
Fig 12: Wave Breaker height:Updrift

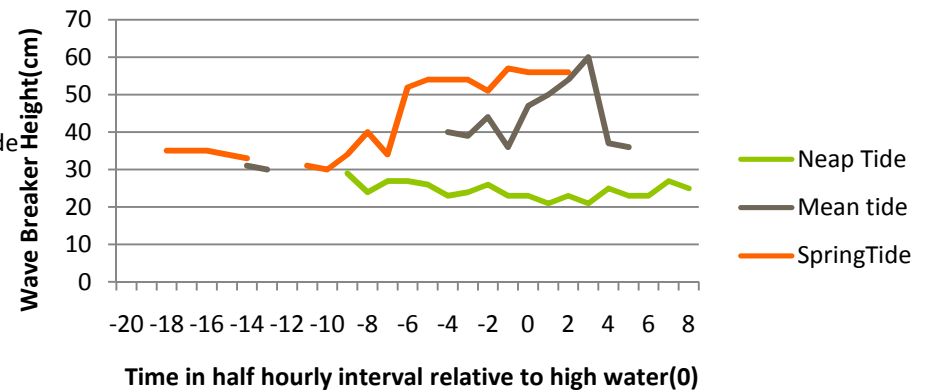
Fig 13: Wave Breaker Height: Downdrift

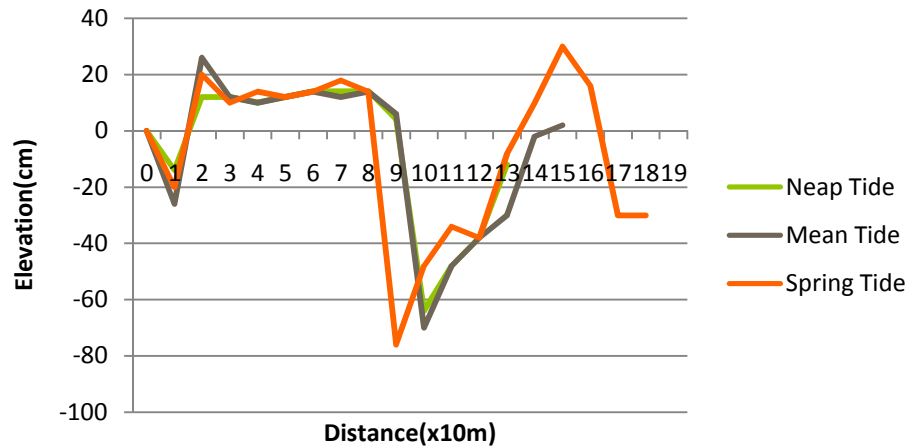
Fig.14. Beach Profile: Updrift-Station 1

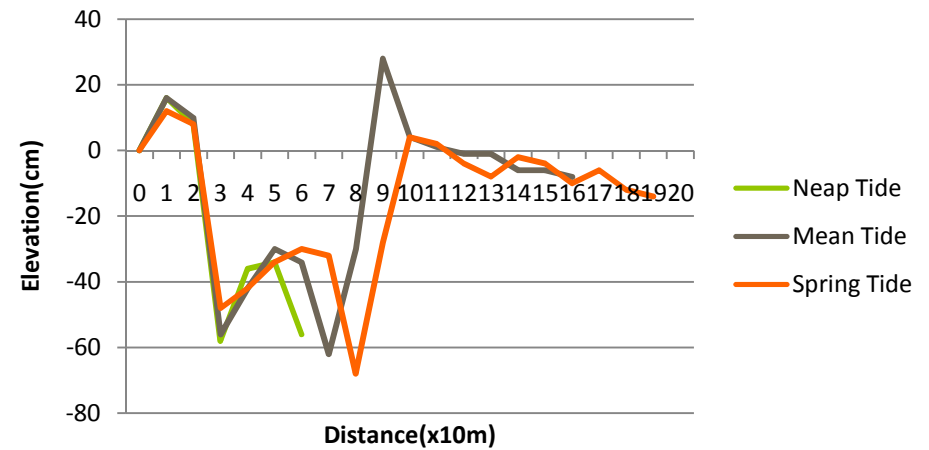
Fig.15. Beach Profile: Updrift Station 2

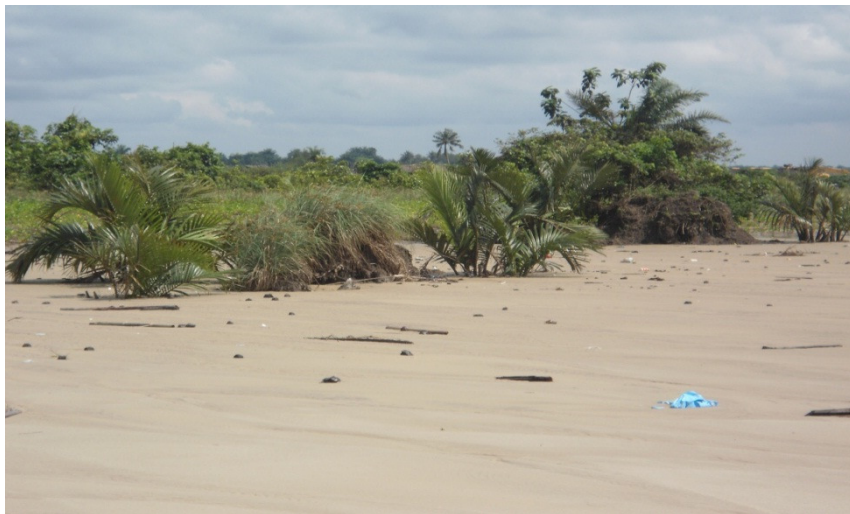
Plate 5: Backshore - Updrift Station 1

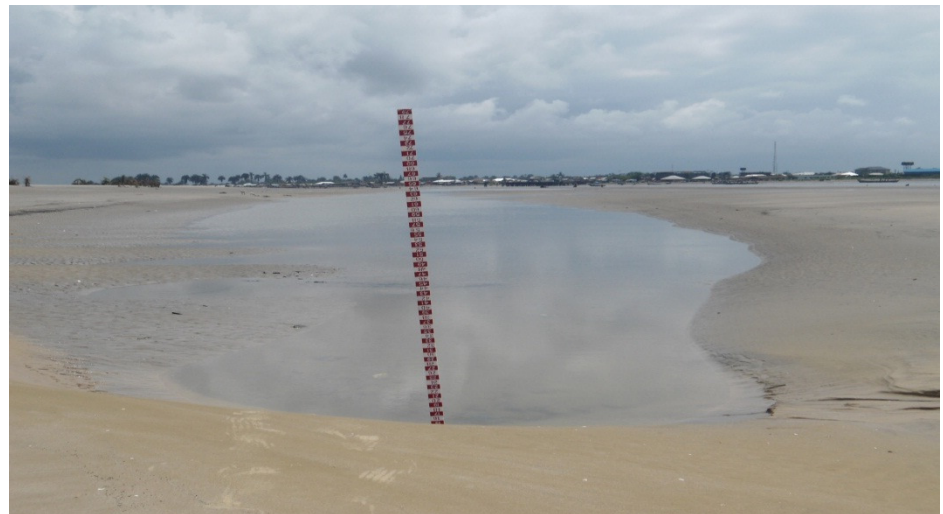
Plate 6: Foreshore –Updrift Station 2

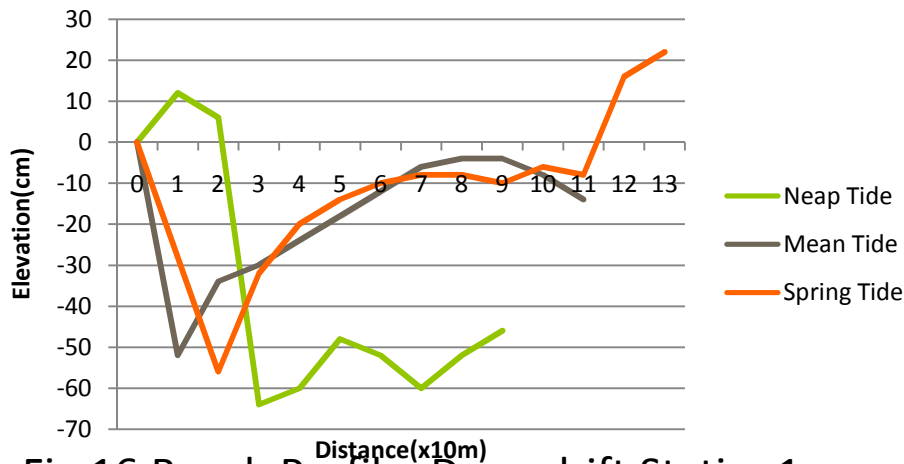
Fig.16. Beach Profile: Downdrift Station 1

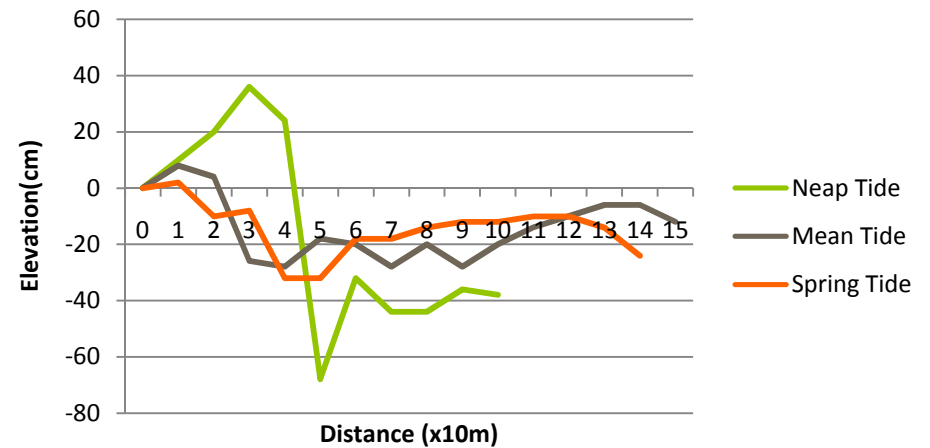
Fig17. Beach Profile: Downdrift-Station 2

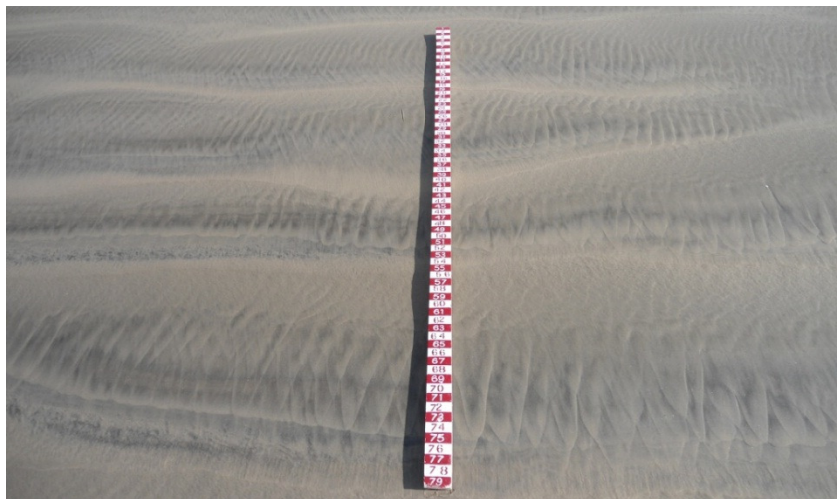
Plate 7: Foreshore- Downdrift Station 1

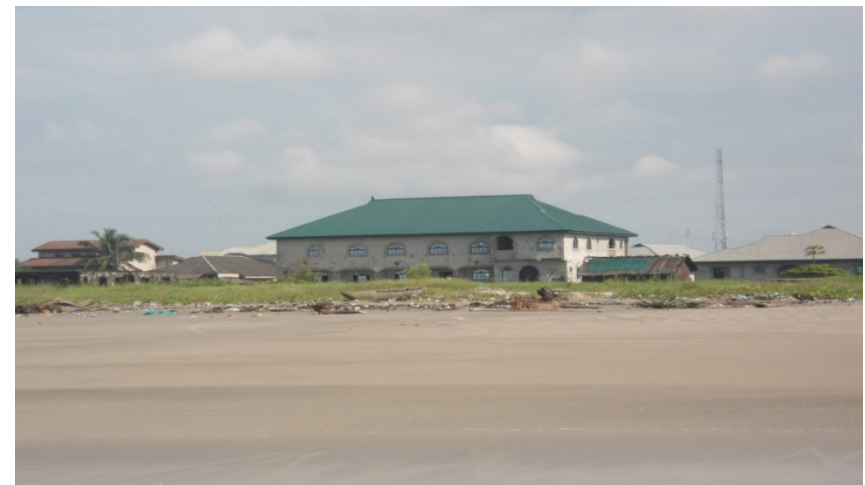
Plate 8: Foreshore- Downdrift Station 2

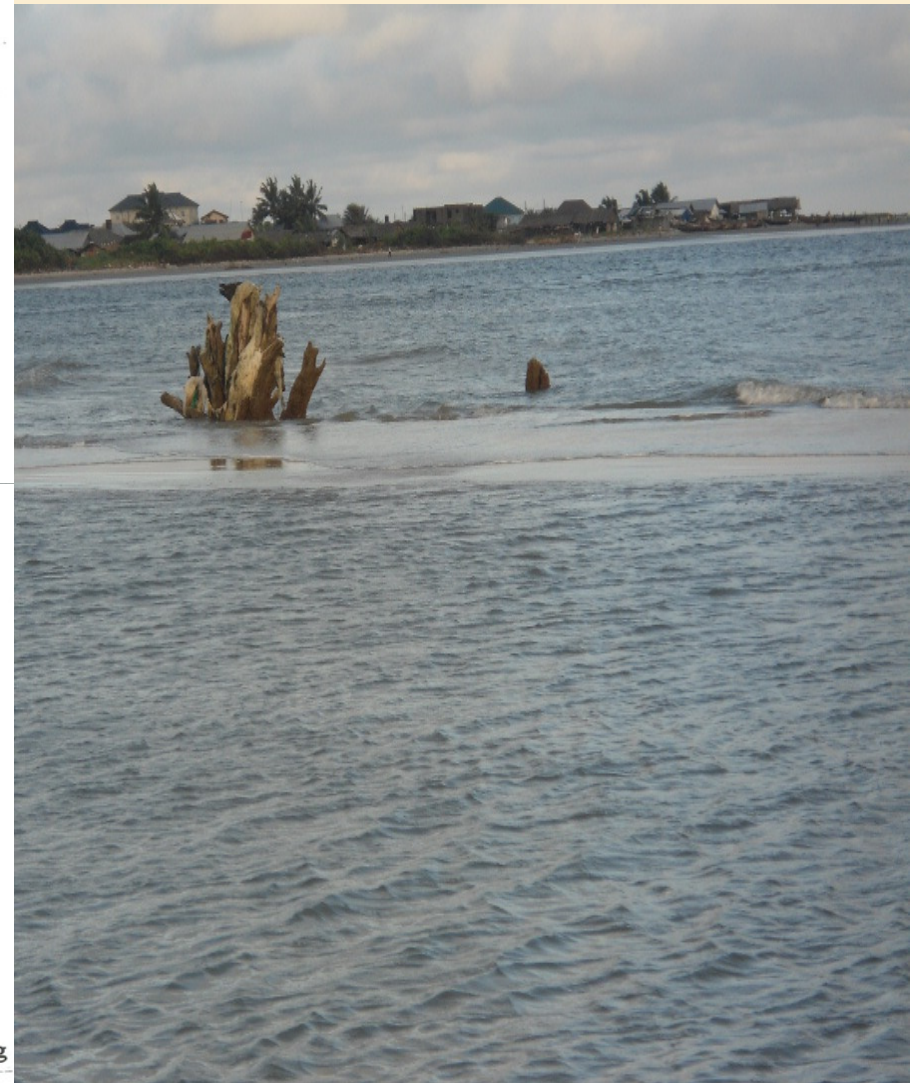
Plate 9. Offshore sand bar –Updrift.

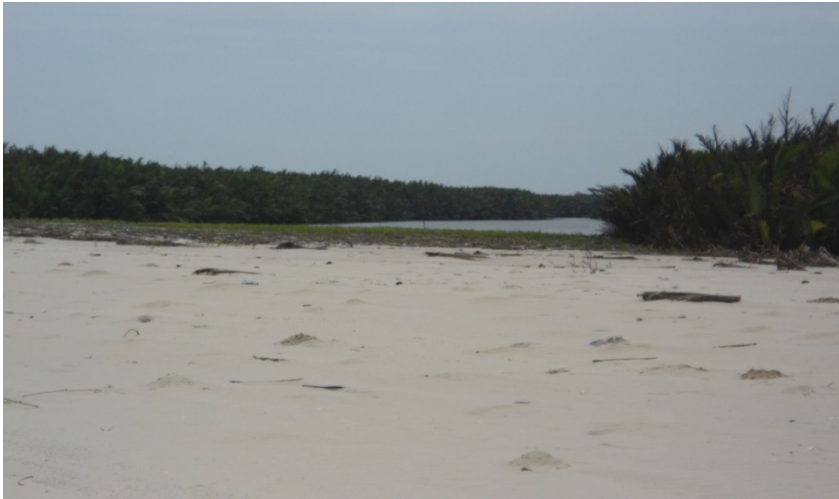
Plate 10 Stubb's Creek sealed-up with sediment during storm surge in

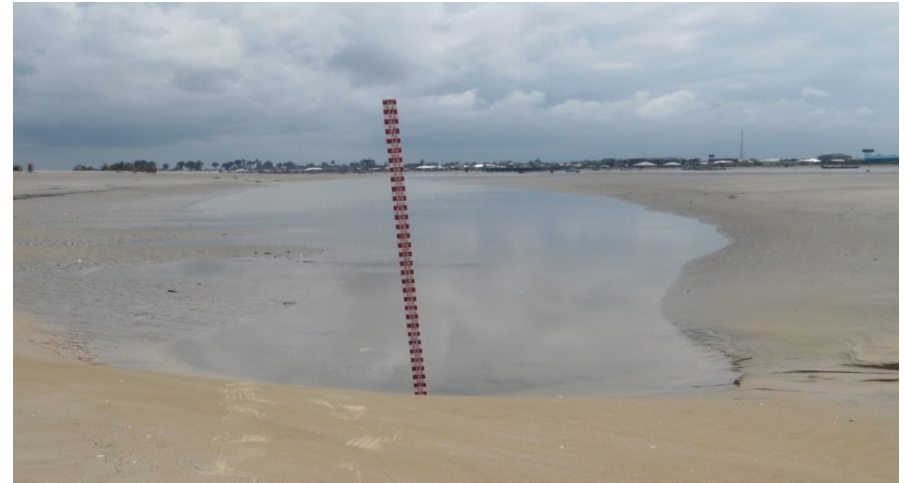
Plate 11: Foreshore trough at updrift beach

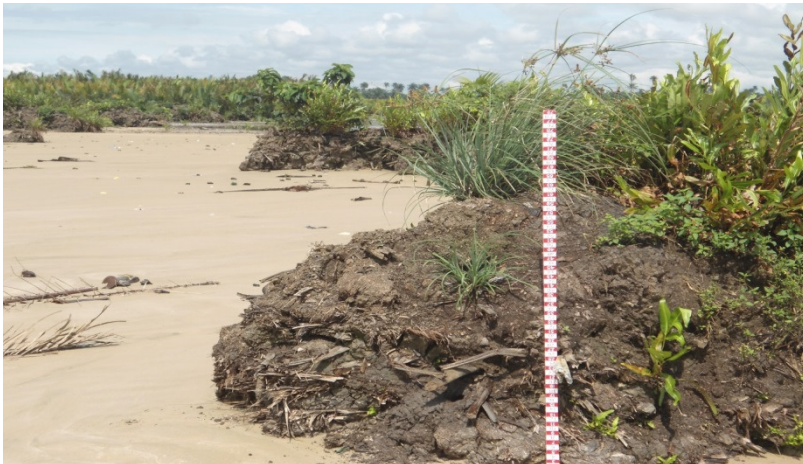
Plate 12: Eroded backshore at updrift beach

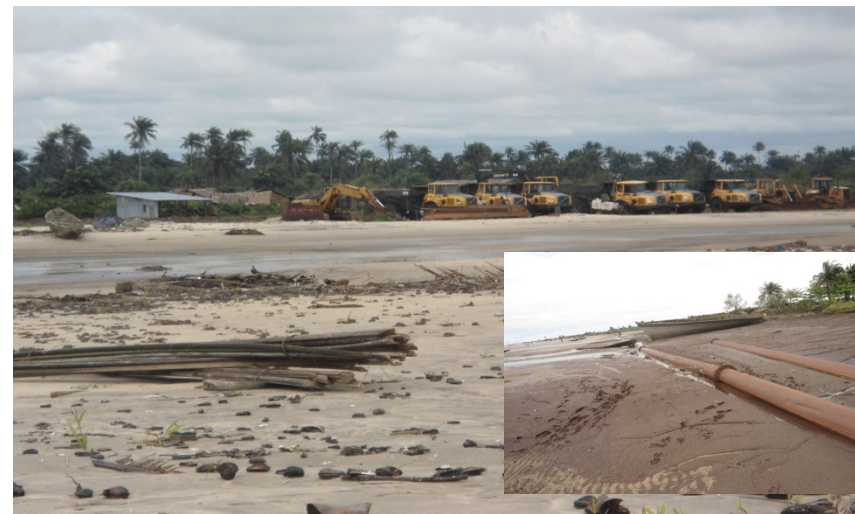
Plate 13 shoreline retreat due to storm surge event at the updrift

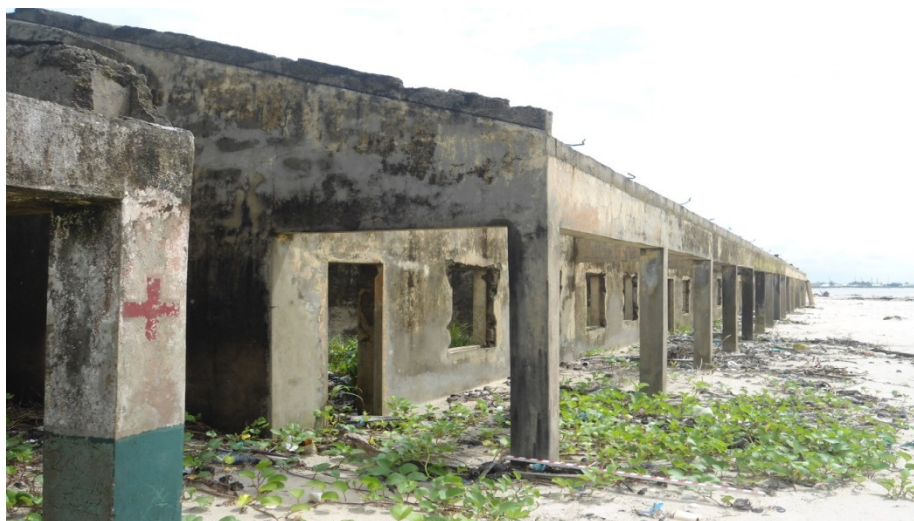
Plate 14: Former Itak Abasi primary School damaged by storm surge in 2011

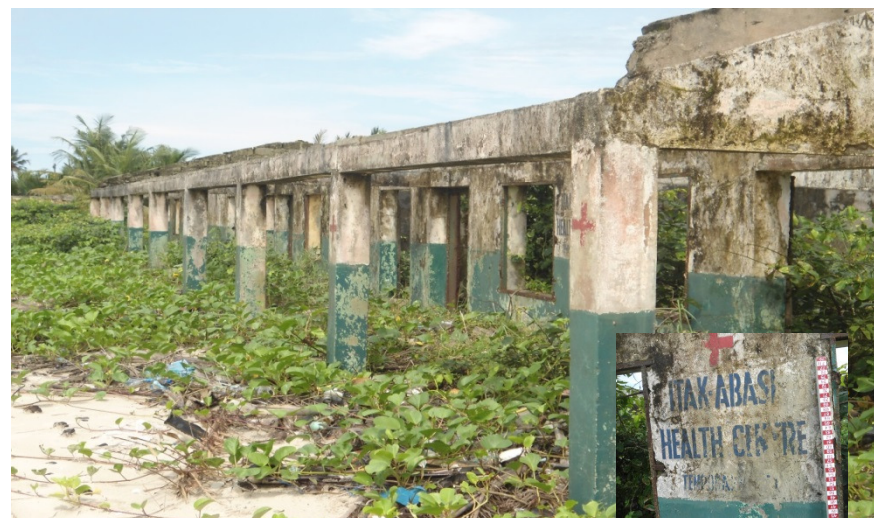
Plate 15: Former Itak Abasi Health Centre damaged by storm surge in 2011

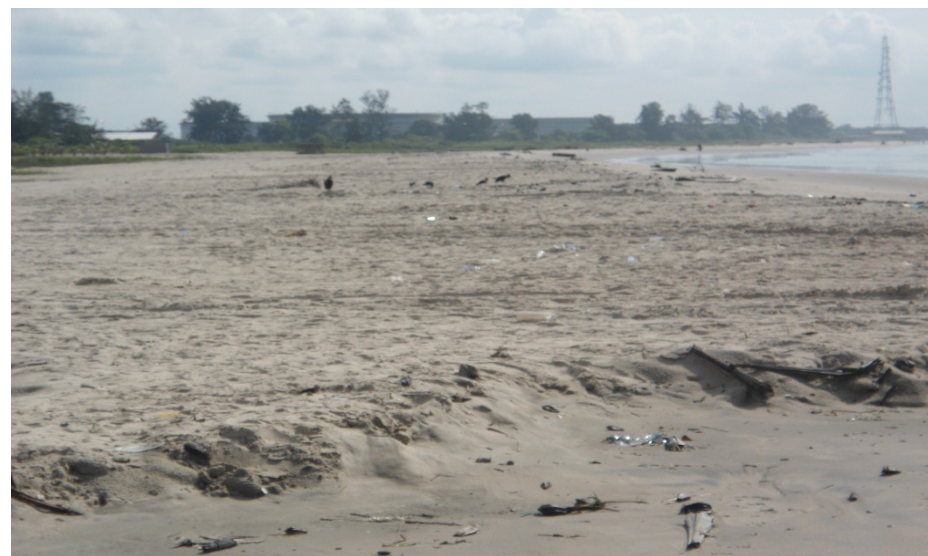
Plate 17: sediment accretion at downdrift beach
