**Ar. Sayed Ahmed**  
Anhalt University of Applied Sciences  
Dessau  
Germany

**collected short stories!**  
A modern monument with contradictions

# Törten Estate Walter Gropius 1926-28

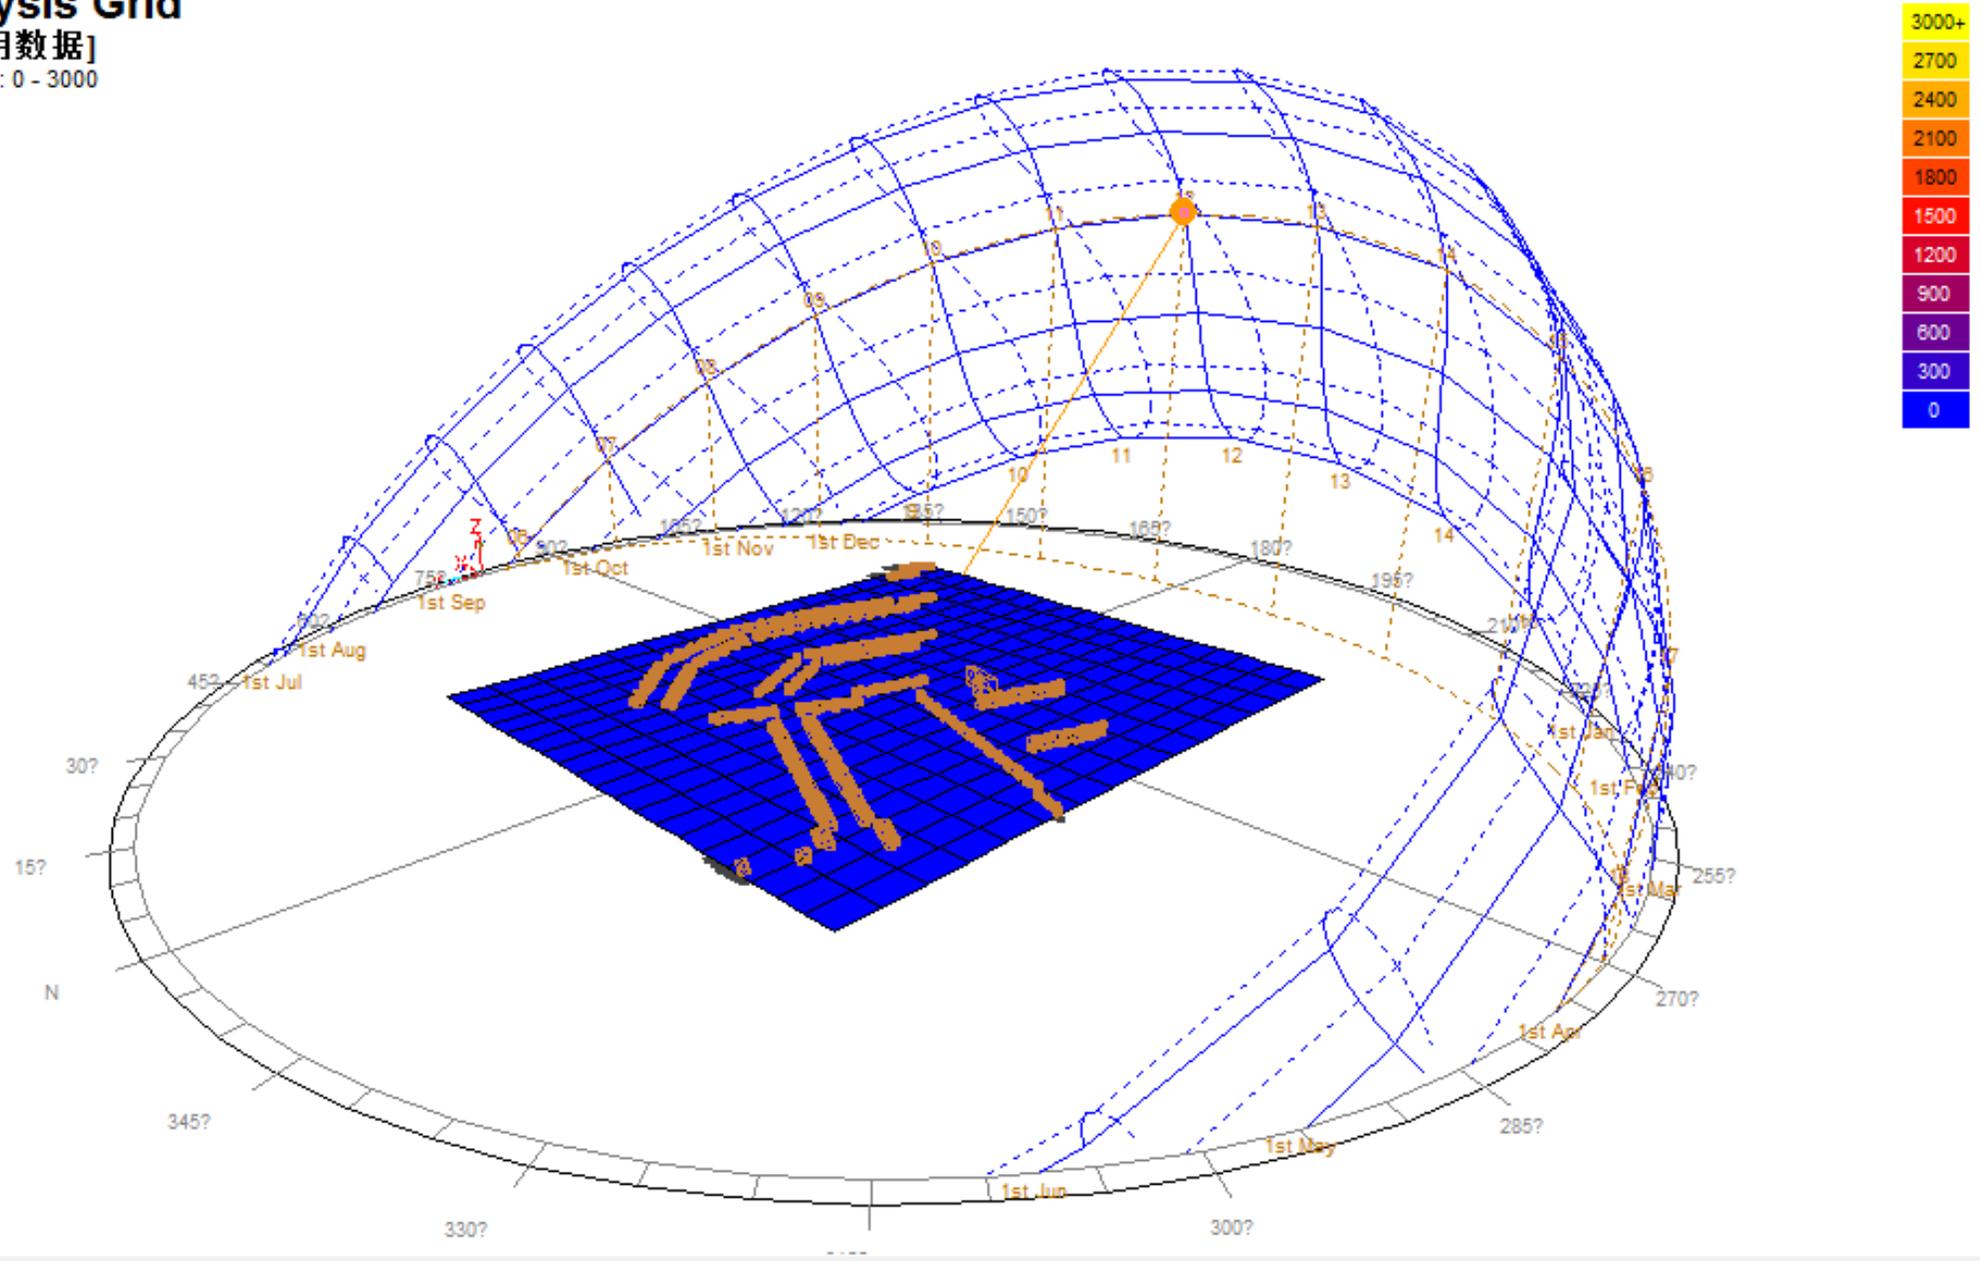
# Winter solstice Sunlight Analysis

**location:**

13.25 east longitude, latitude 52 ° 30

**time:**

start:8:00 over:16:00

**date:**

Winter solstice

**Accuracy:**

60mins

**grid:**

1000

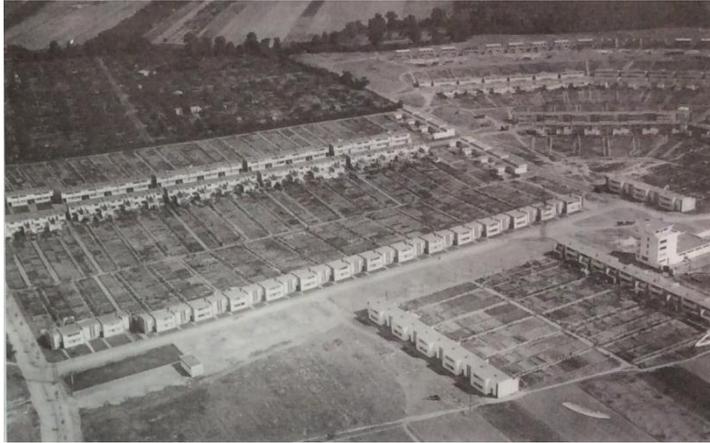
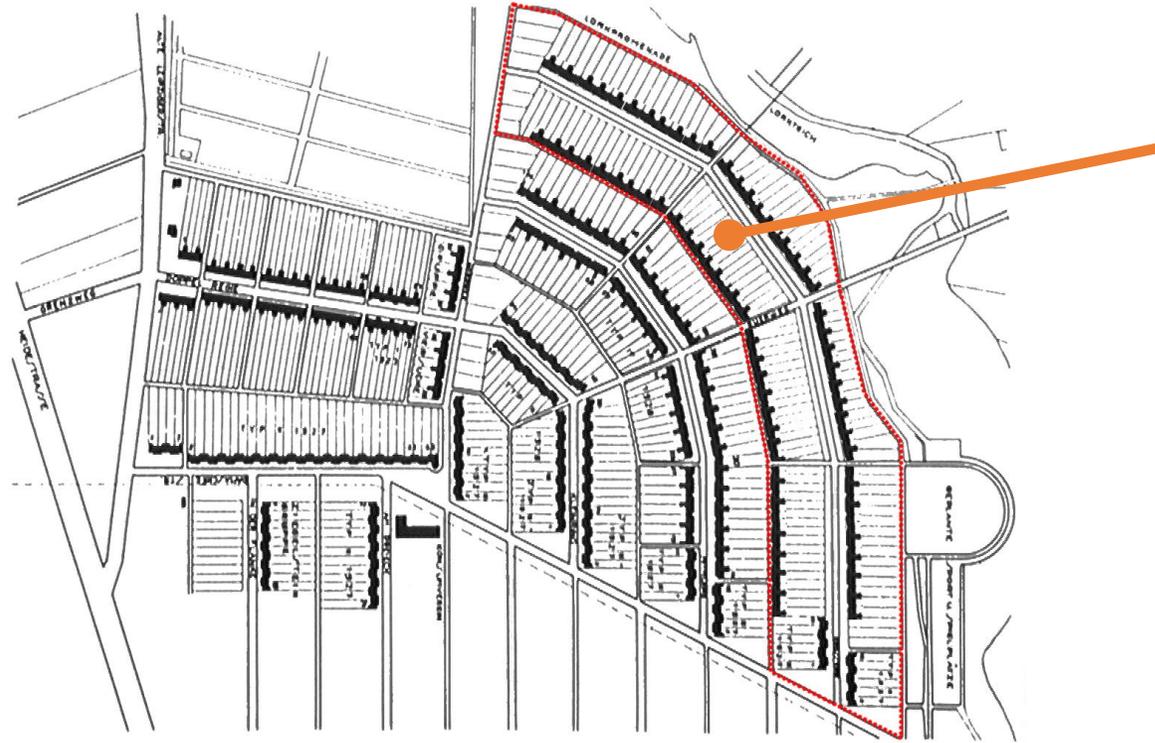
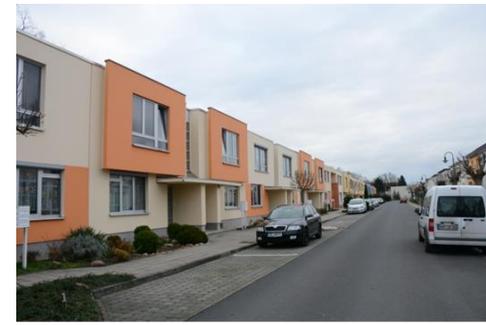
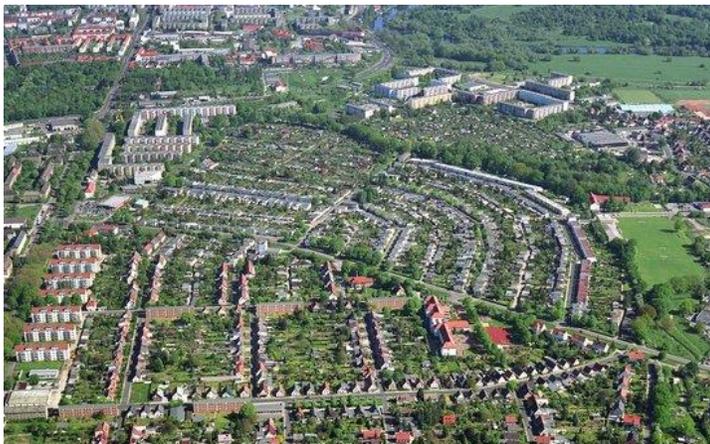
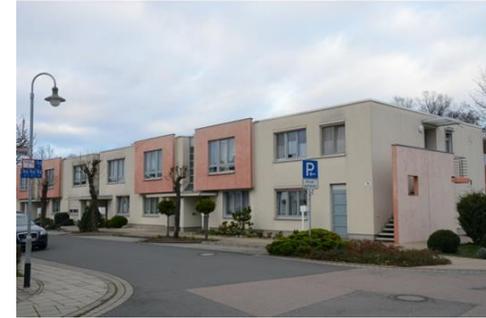
**Phase 1** houses have the distinctive strip windows and steel front door. Prismatic glass blocks have been used to one side and above the front door to allow light in hallway.

**Phase 2** houses' glass blocks have been used to provide light to the staircase (a little like the large staircase windows in the Masters' houses). These were slightly smaller than Phase 1 houses but had a separate bathroom on the first floor.

**Phase 3** houses were smaller than the houses from the earlier two phases. it has a "split level" design with some of the living rooms in the basement. That's why the strip of windows at the bottom of the facade is actually high up in the room on the lower level. They include the boiler and the earth closet toilet. (<https://greatacre.wordpress.com/2014/04/01/the-trten-estate-dessau/>)

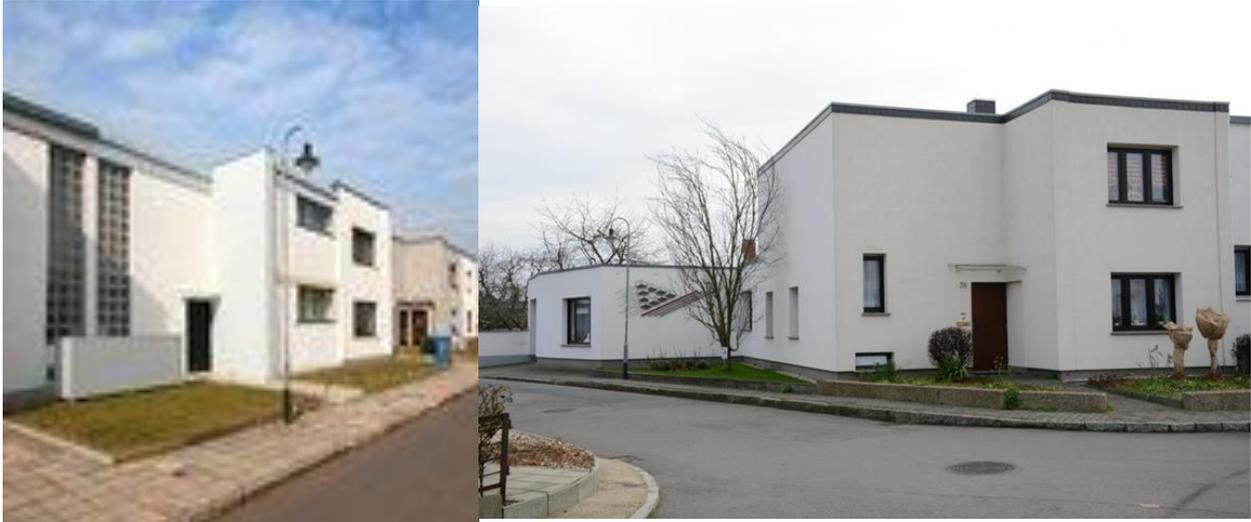
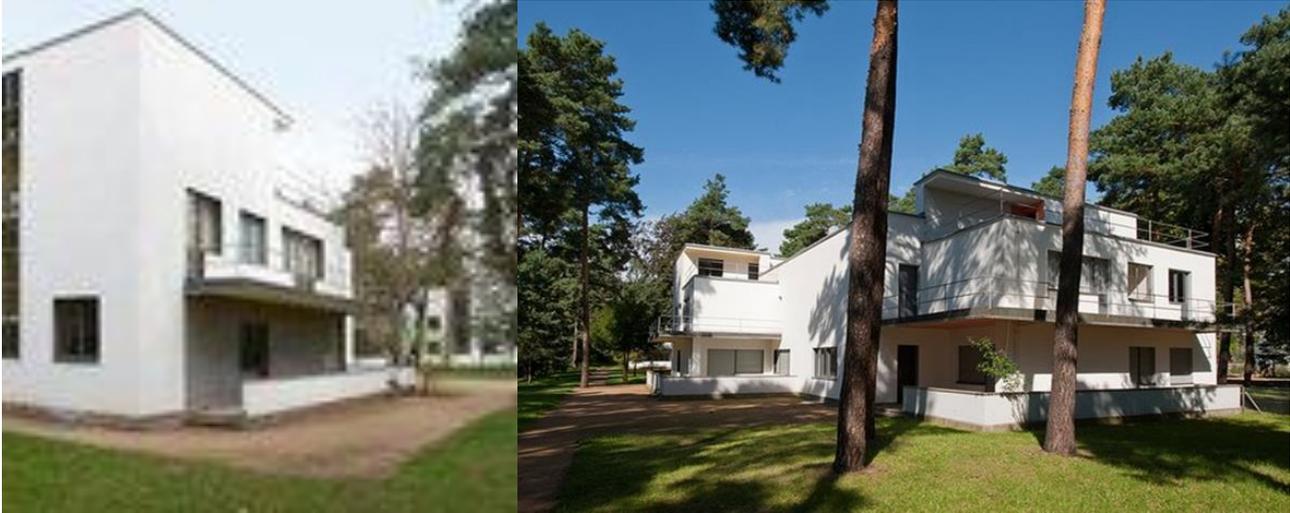
**Masters' Houses by Walter Gropius  
Built 1925-1926**

Interleaved cubic corpora of different heights.

Vertical rows of windows on the side façades

Provided lighting for the stairways , but in master houses the large glass windows for studios.

The façade of the Director’s House was the only one to feature asymmetrically arranged windows.

Both houses are painted in light tones and the window frames, the undersides of balconies and down pipes in stronger colors.

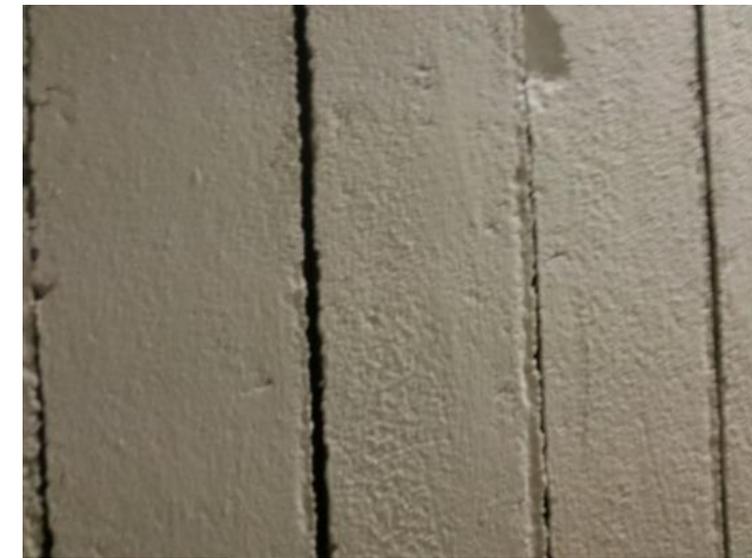
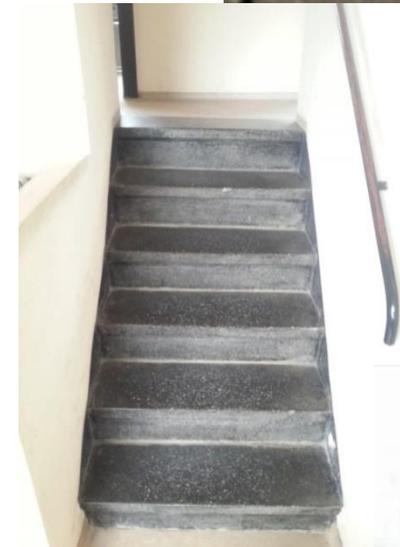
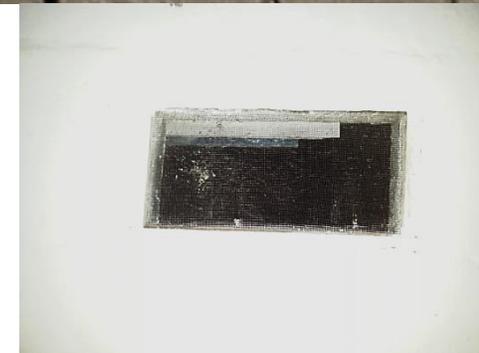
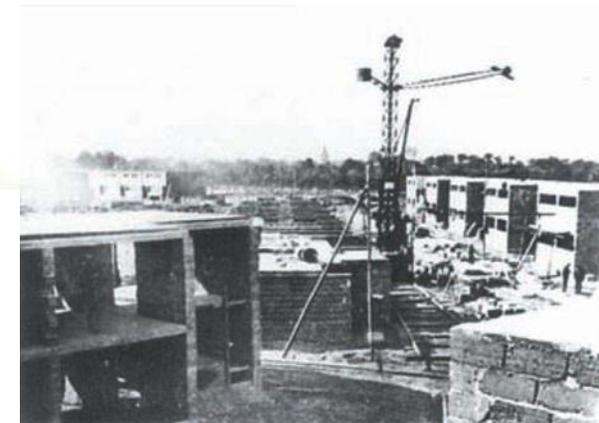
The structural precast concrete joists were prefabricated on-site and transported via small wagons and moved by crane, sand and granite for concrete were collected on-site. Concrete blocks, slab, beams all were produced onsite .

The load bearing walls were made of prefabricated and inexpensive hollow slag-concrete blocks measuring 22.5 x 25 x 50cm and the ceilings with reinforced concrete joists tightly bolted together side by side.

The longitudinal walls were made of non load bearing filling walls consisting of two 6cm thick cinder concrete and block with an air pocket of 1cm between them.

Floors spanning between load bearing walls, external walls were sealed with light concrete block work.

**Alternatives would have been to have the concrete prefabricated off-site under controlled conditions. The tight construction schedule did not allow for certain materials, for example bricks, to attain maximum strength causing cracks to occur. The bricks could have been moulded at the beginning of the construction process giving them ample time to dry before usage.**

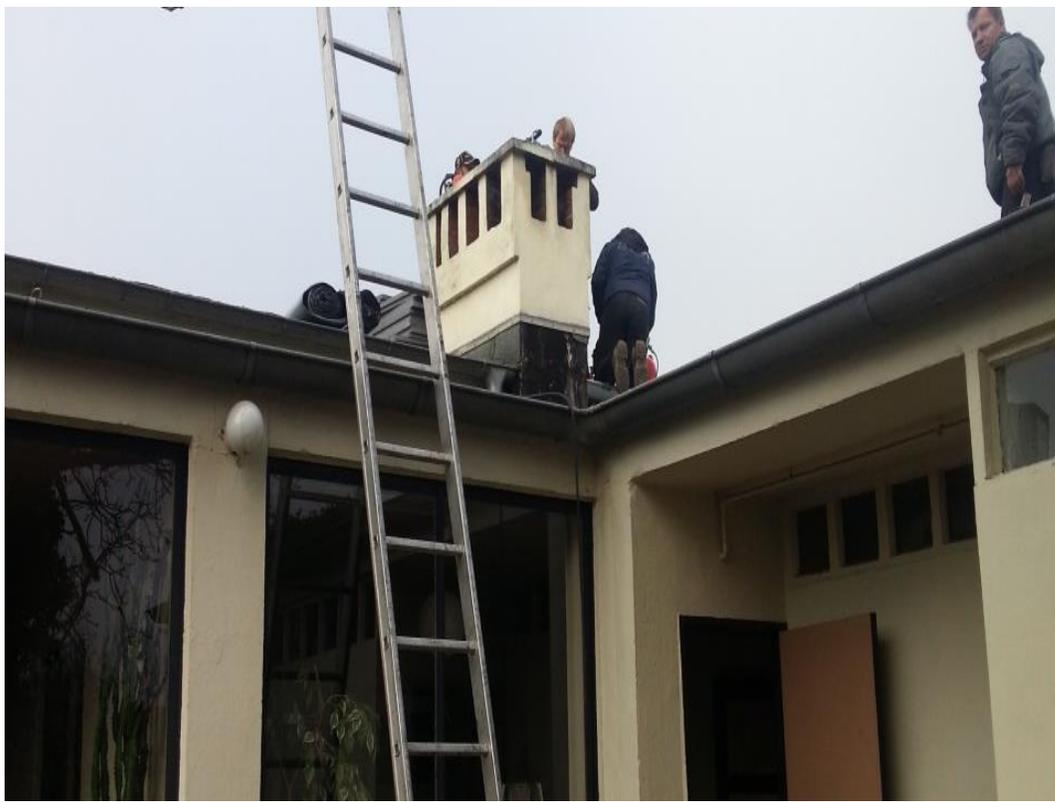
Self-renovation works is being carried out

Long after project completion, defects in design and construction became obvious. Bad insulation and cracks in the walls were examples of defects noticed.

Soon after, residents made numerous alterations to deal with the problems. The first changes carried out in 1934 , were to reposition too-high windows, then plans were altered to suit their insulation.

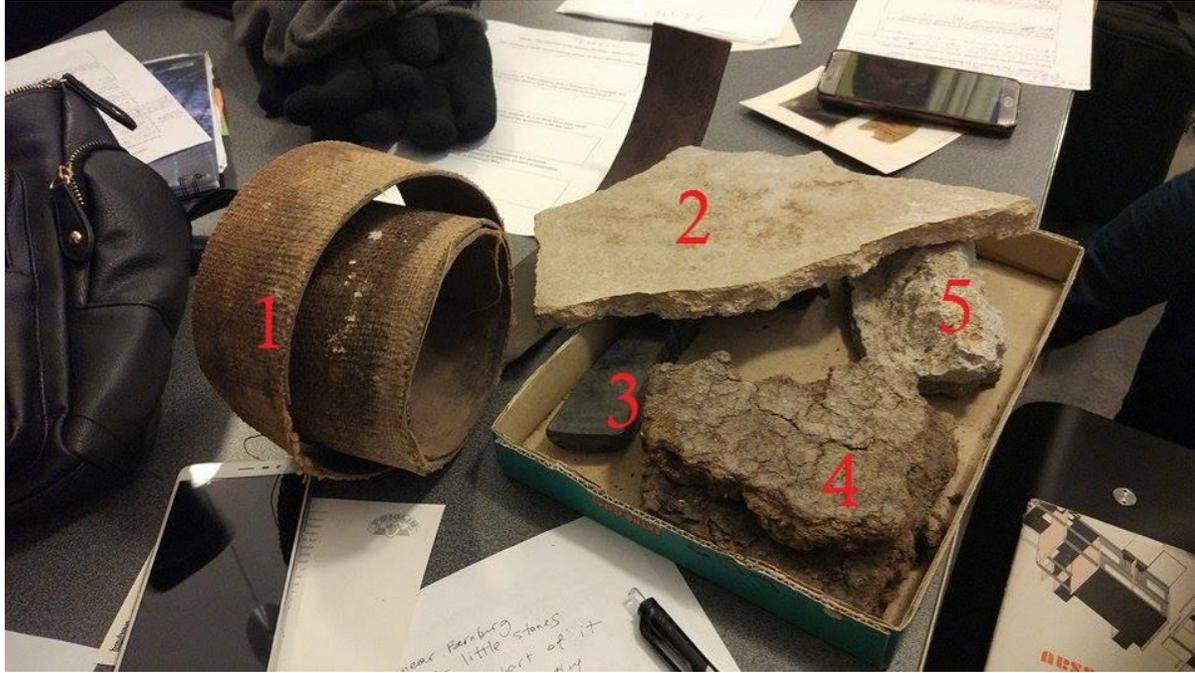
## Triolin

A plastic floor covering of Bauhaus Buildings and in the Masters' Houses instead of linoleum. Optically, Triolin can hardly be distinguished from linoleum.

Developed in the 1920s in the search for a low price substitute for linseed oil.

mainly composed of nitrocellulose, fillers and gelling agents applied to a hemp fiber fabric, jute from Bengal (today's Bangladesh).

Triolin floor in the office of Walter Gropius in Bauhaus Dessau is the only example left today. Instead of organic material, jute some **synthetic fibers like Acrylic, nylon, polyamide** could be tried to achieve sustainability. This is the only required alternative for conservation of flooring.

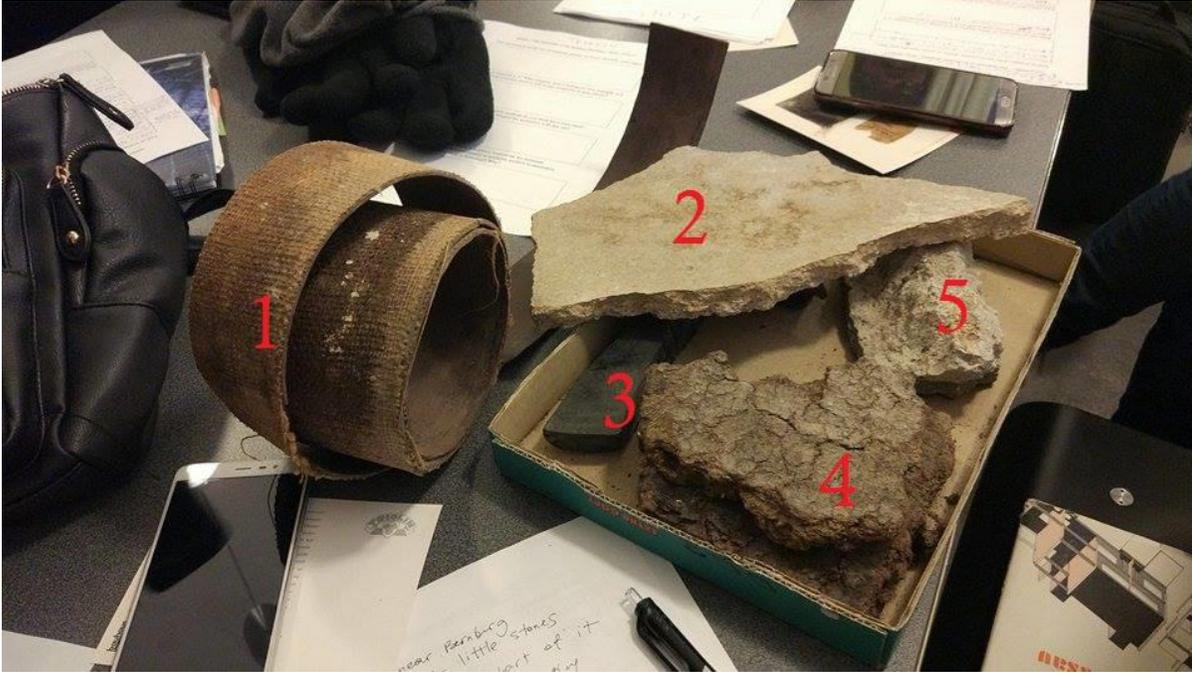
## Magnesite

Magnesite coating to the surface of the internal floor was regularly used in unit construction and Local Authority housing between 1945 to 1960.

Installed mainly as a leveling compound to provide an adequate level surface to the floor. This is specialised cementitious product which is based on magnesium oxychloride (or magnesium oxysulfate) cements. The most popular form comprises the reaction between magnesium and solution of magnesium chloride. Its appearance is brick red in color and straw yellow too.

They are laid at anything between 15-25mm thick. Typically laid between 10-25mm thick, but two coat applications could be up to 50mm thick.

This is a cork type material thus provides a softer finish to the floor. It is also extremely durable, resistant to oils and grease, lightweight, and even noncombustible and cooler. But it is electrically conducting.

The problem occurs when water entry leaks, particularly around leaking windows or patio door units like Torten estate. Problems appear when on top of magnesite any impervious material is installed. When it becomes damp, or wet, it sets up a chemical reaction with the steel reinforcing to the main part of the concrete structure, or floor. This accelerates rust which attacks the structural core of the floor slab and building. In extreme cases, the floor in the affected areas can noticeably lift and produce awful smells when the filler rots. They are very vulnerable to humidity. Magnesite flooring is hygroscopic, absorb dampness.

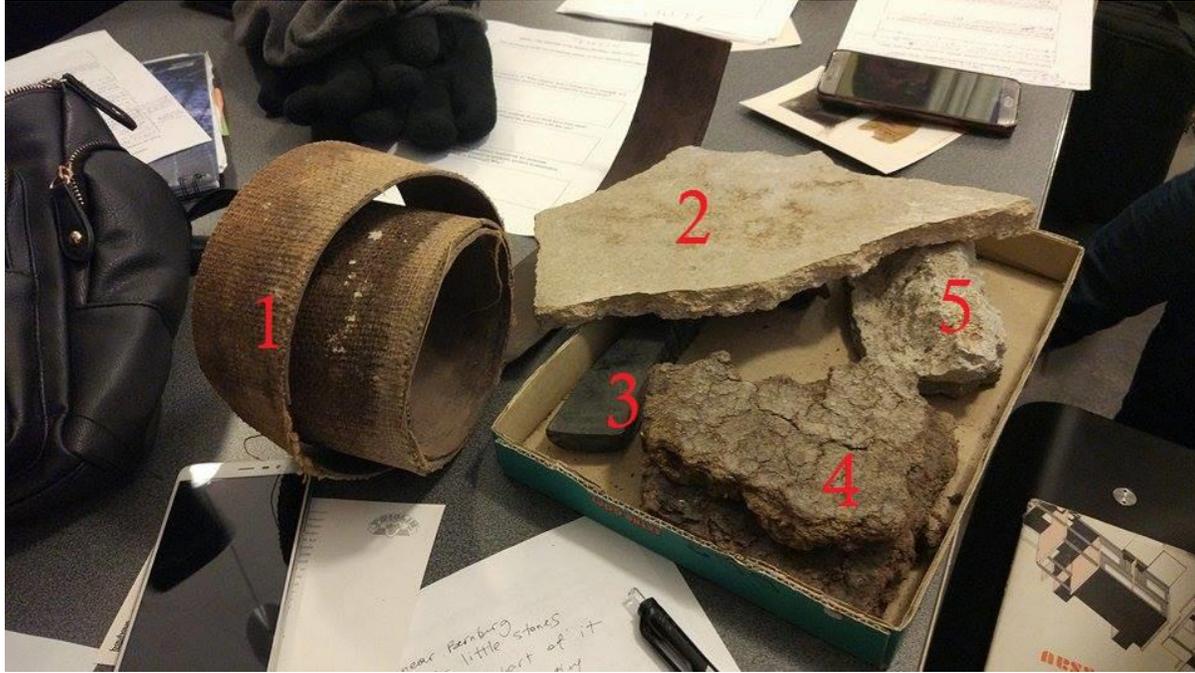
Black opaque glass cladding  
Only a cladding material for column. 25,4 mm thickness.

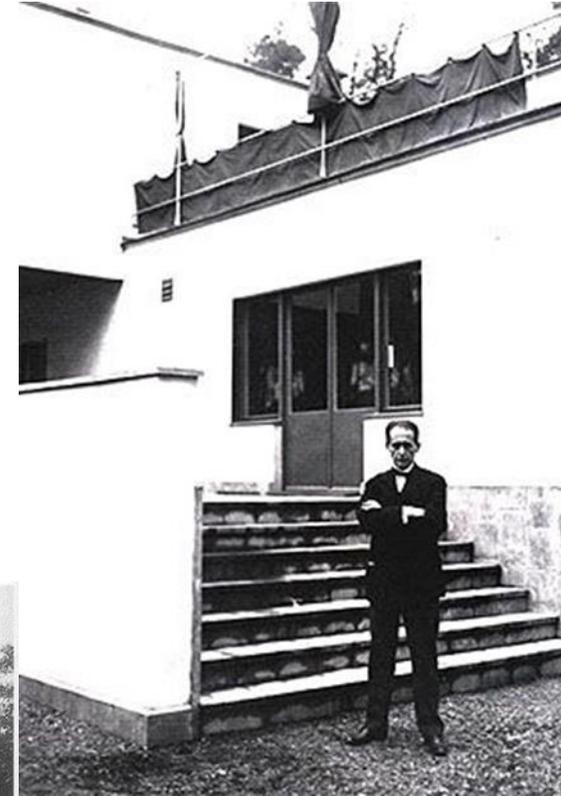
- 1 Triolin flooring
- 2 Magnesite flooring
- 3 **Black opaque glass**
- 4 Torfoleum insulation
- 5 Concrete

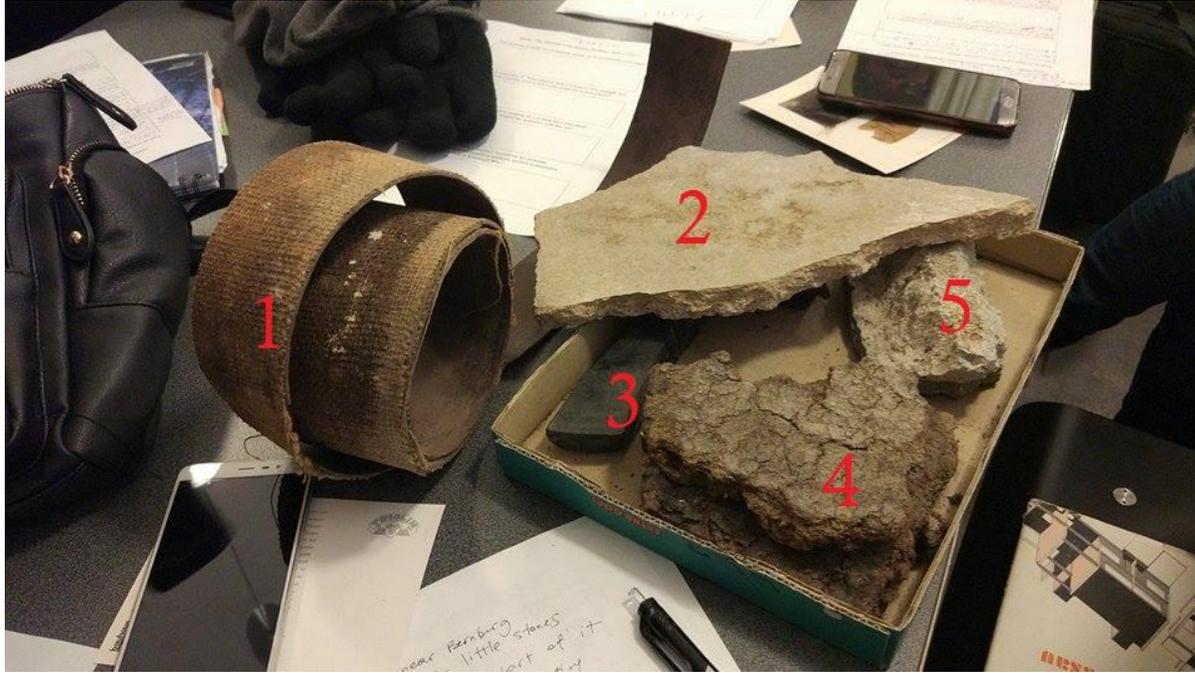
## Torfoleum

The external walls are clad with insulation boards from so called Torfoleum. It is an impregnated pressed peat board with jute fiber and cattle hair. Generally it is of 50 mm, as there are two boards of 25 mm fixed in overlapping bonding. The buildings were insulated external walls of roughly 330 mm.

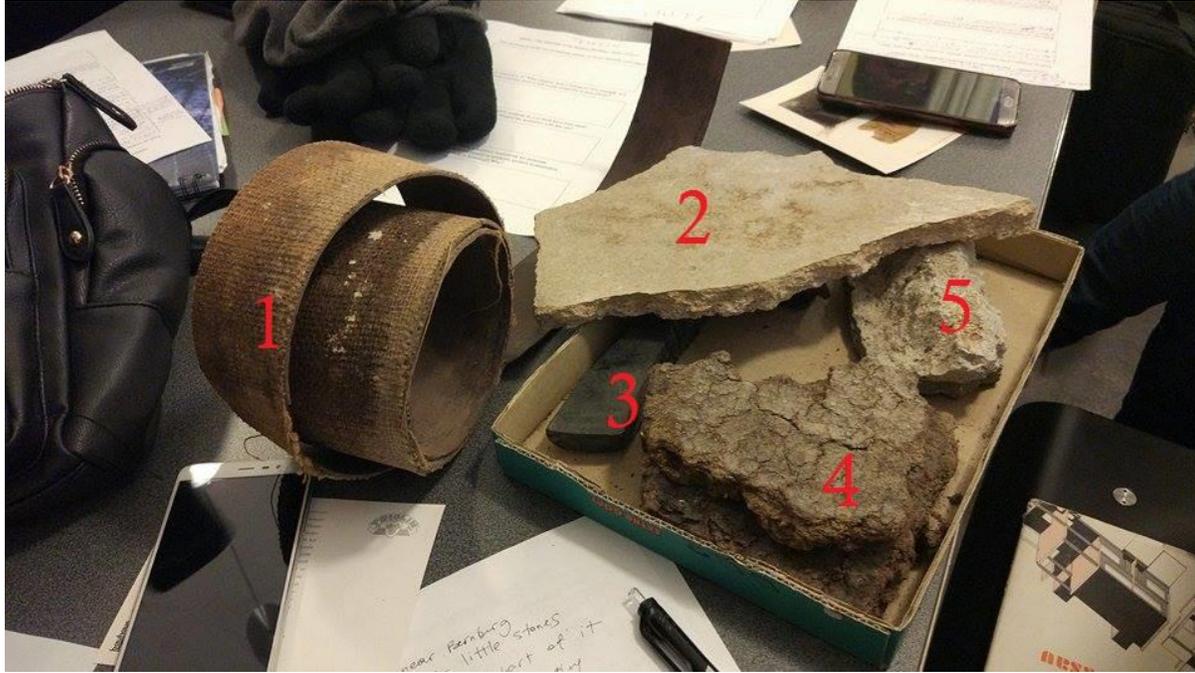
## Concrete

The structural precast concrete joists were prefabricated on-site and transported via small wagons and moved by crane. Load-bearing walls were built using prefabricated slag concrete hollow blocks and the ceilings **Rapidbalken (precast concrete joists)**, prefabricated on-site to reduce the cost of construction. The floors concealed with reinforced concrete beams. **Fly ash** was real problem on that time. The **cement** used in the construction was very **porous as it contained too much gravel**, while the layer which covered the frame of the building had too little, which is why the **iron frame has oxidized**.

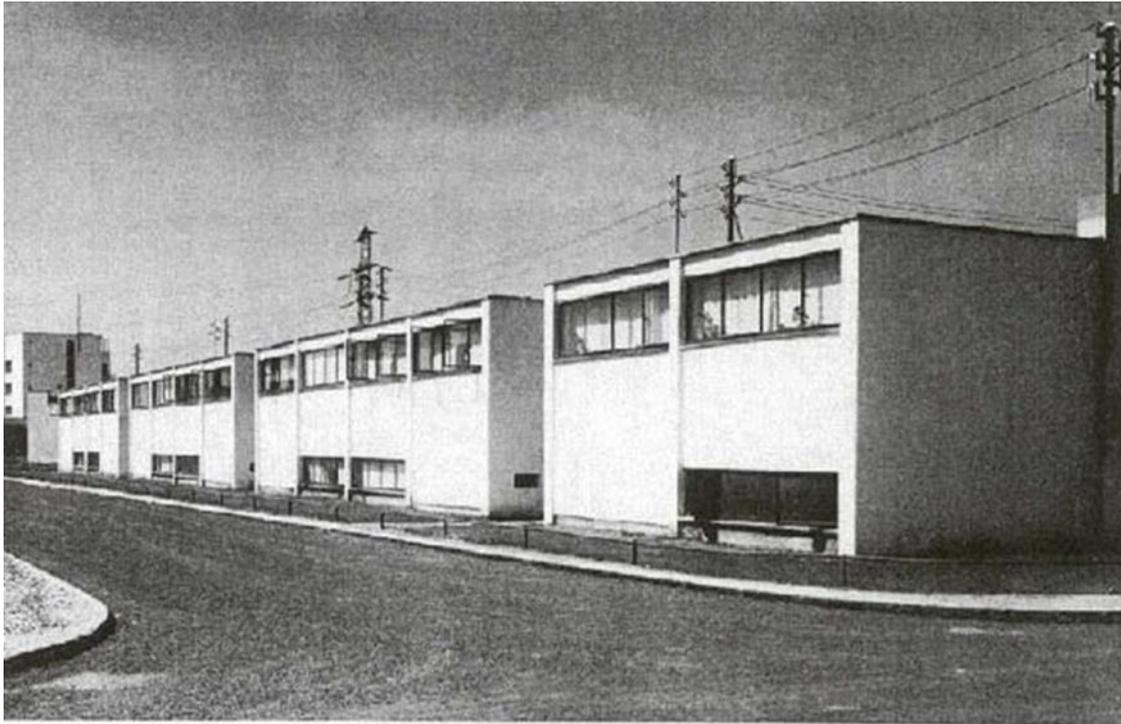
**Nordweg. Ansicht von Nordosten, ca. 1928. Haustyp sietö IV. Im Hintergrund das Gebäude des Konsumvereins (Gropius 1928). Auf den Dächern sind die Masten der oberirdischen Stromzufuhr zu erkennen**
